Combined use of deformation and structural analysis for the structural damage assessment of heritage buildings: A case study in the Liguria region (Italy)

Giulio Lucio Sergio Sacco, Chiara Ferrero^{*}, Carlo Battini, Chiara Calderini

Department of Civil, Chemical and Environmental Engineering, University of Genoa, Via Montallegro 1, 16145 Genoa, Italy

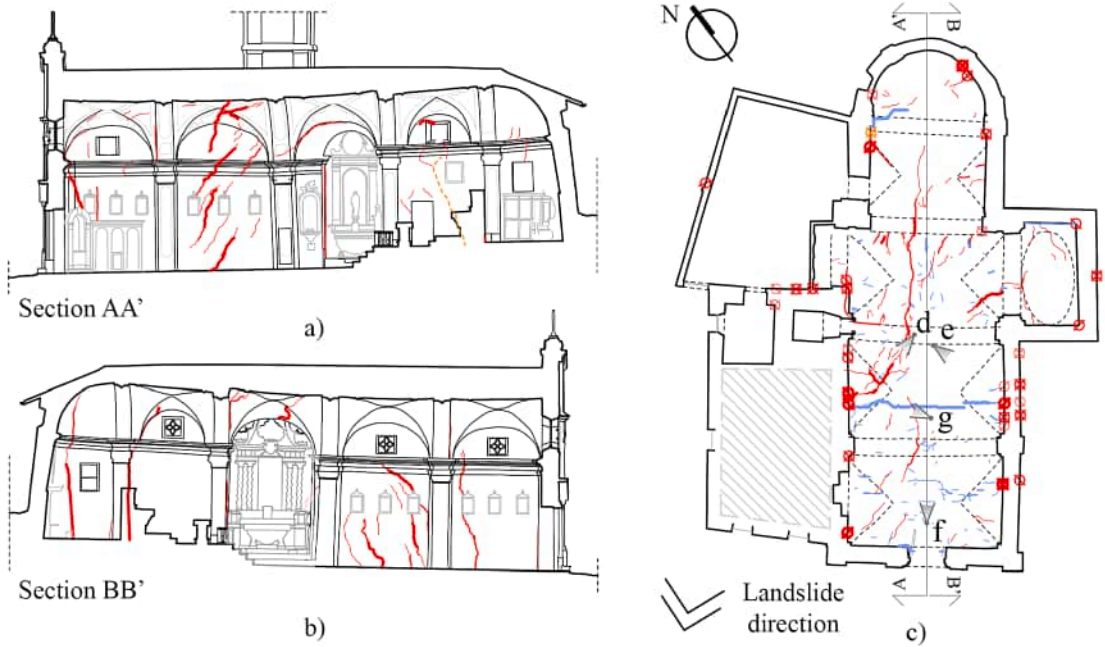
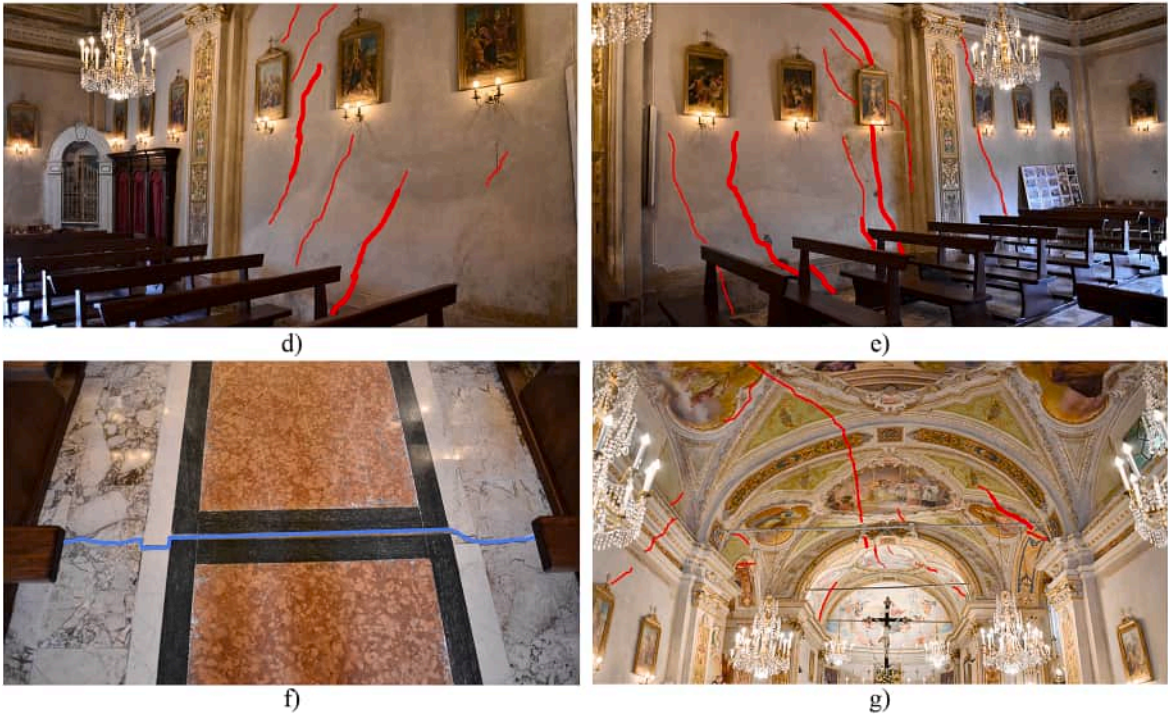
Severe and extensive damage was observed in the walls. In the nave, the most significant damage was detected in the second bay behind the façade. In this bay, the left (north-western) longitudinal wall is affected by a series of medium to large diagonal cracks progressing upwards towards the apse (see Fig. 5a-d). One of these cracks develops from the level of the ground. Similarly, the right (south-eastern) longitudinal wall exhibits a series of medium to large diagonal cracks propagating from the level of the floor and developing upwards towards the apse (Fig. 5b-e). In addition to these cracking patterns, vertical or slightly inclined cracks developing upwards from the level of the ground are observed in the right longitudinal walls of presbytery, apse, and first bay of the nave behind the façade (see Fig. 5b). Lastly, two large cracks are present in the left longitudinal walls, one located in the first bay behind the façade and the other in the presbytery (Fig. 5a). Both cracks are diagonal and progress upwards towards the façade. The crack in the presbytery was repointed before 2018 and no sign of partial reopening was observed in either 2018 or 2020.

Severe damage was observed also in the floor. In the second bay behind the façade, a large crack (about 12 mm wide) cuts the floor of the entire nave, propagating transversally between the longitudinal walls (see blue line in Fig. 5c-f). This crack is in continuity with the cracks affecting the longitudinal walls. Thin to medium cracks, oriented perpendicular to the direction of the landslide acting in the area, were also observed in the floor of the first bay and the northernmost part of the right chapel (see blue lines in Fig. 5c).

Differently from walls and floor, arches and vaults do not exhibit severe cracking (see Fig. 5c). A thin to medium longitudinal crack, oriented in same direction as the landslide, cuts the barrel vaults of nave and presbytery approximately at mid-span (Fig. 5c-g). This crack changes direction while progressing towards the left longitudinal wall of the nave on one side and the wall of the presbytery on the other side. Thin cracks with a slight concentric pattern are also detected around the belltower (Fig. 5c). Lastly, very thin diagonal cracks are widespread in the nave, presbytery, and right chapel.

Fig. 5. Damage survey of San Carlo Borromeo church in Cassinengo: a) crack pattern in plan (the direction of the slow-moving landslide acting in the area is indicated with an arrow), b) crack pattern in elevation (section AA', left longitudinal wall), c) crack pattern in elevation (section BB', right longitudinal wall), d-e) diagonal cracks in the left (d) and right (e) longitudinal walls of the nave (second bay behind the façade), e) large crack in the floor of the nave, f) cracks in arches and vaults.

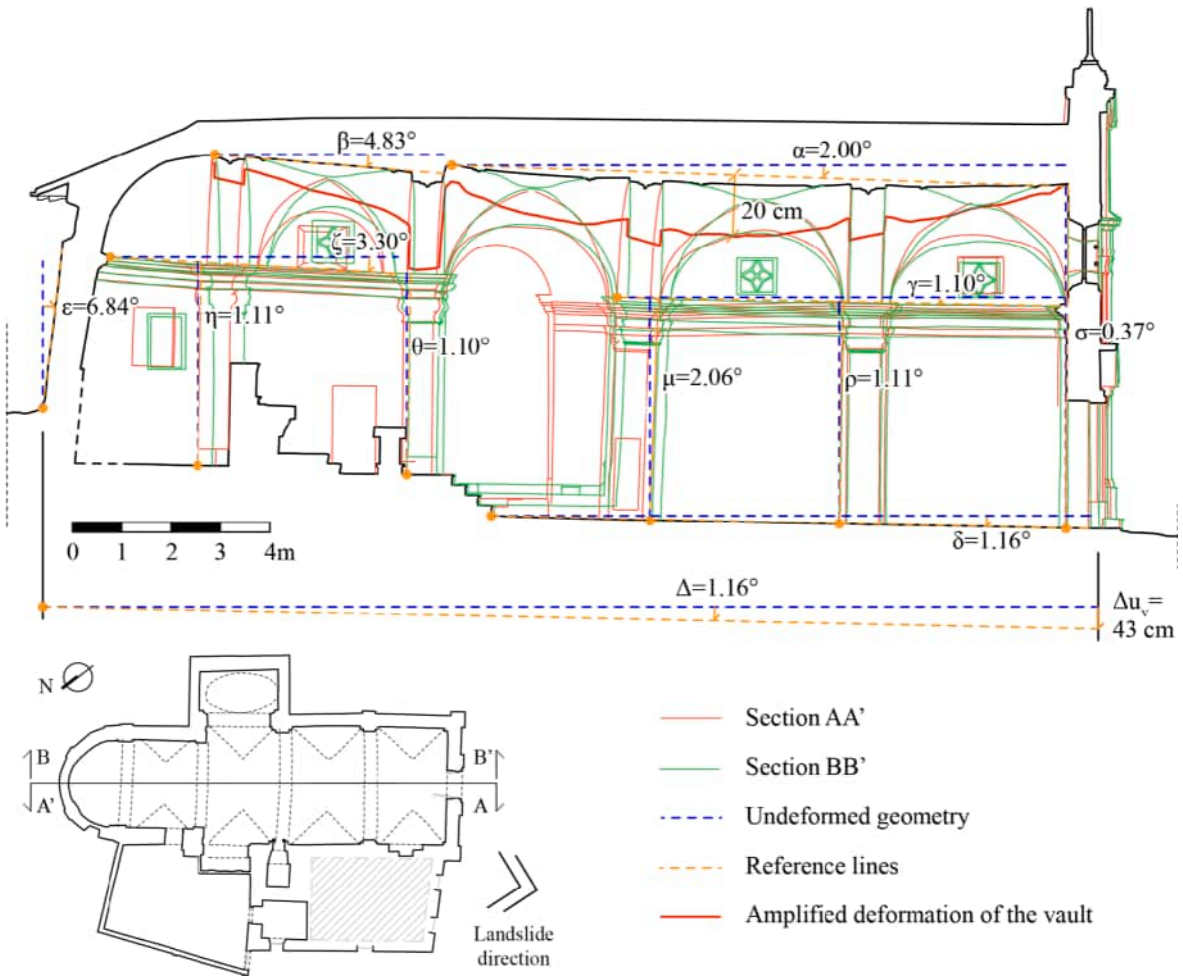
The deformation analysis of the longitudinal sections is shown in Fig. 6. Walls, pilasters, vaults, mouldings, and floors were chosen as the architectural elements to be analysed. For each element, the deformation was estimated by choosing a reference pole of rotation (orange dot in Fig. 6) and a reference line representing the undeformed reference configuration (blue dashed line in Fig. 6) and measuring the rotation between the reference geometry and the surveyed one. The reference line was assumed to be vertical for walls and pilasters and horizontal for floor and mouldings. In the case of the vault of the nave, which exhibits a significant deformation (solid red line in Fig. 6, amplified by ten times), the rotation was measured between the horizontal reference line and a line connecting the two extremities of the vault (orange dashed line in Fig. 6). As shown in Fig. 6, all the architectural elements analysed exhibit a rotation towards valley, in the direction of the slow-moving landslide. This outcome clearly indicates that the entire church experienced a

Fig. 6. Deformation analysis of the longitudinal sections of San Carlo Borromeo church: superimposition of sections AA' and BB'. (Deformed geometry of the vault amplified by 10 times).

global rotation in this direction. The most significant rotations were observed in the apse and presbytery. The vault of the presbytery, the apse wall, and the mouldings were found to be rotated with respect to the vertical by about 4.83° (see angle β in Fig. 6), 6.84° (angle ϵ), and 3.30° (angle ζ), respectively. In the nave, the floor and the mouldings show a smaller rotation of 1.16° (angle δ) and 1.10° (angle γ), respectively, while the barrel vault exhibits a rotation of 2.00° (angle α) in addition to a deflection of about 20 cm in the centre of the second bay (see Fig. 6). All the pilasters present a rotation of about 1.1° except for the second one from the façade, which shows a larger rotation (2.06° , angle μ). No significant rotations were detected in the façade. The larger rotations measured in the presbytery and apse compared to the nave can be explained considering that the presbytery and the apse were built before the nave and, thus, they may have experienced deformations for a longer period of time (see Section 2.1). Due to the uncertainties about the historical information, the rotation of the floor of the nave was conservatively chosen to represent the overall rotation experienced by the church. By applying a rotation of 1.16° to the whole church and placing the rotation pole at the exterior of the apse (see angle Δ in Fig. 6), the vertical displacement between the apse and the façade (Δu_v) can be estimated at about 43 cm.

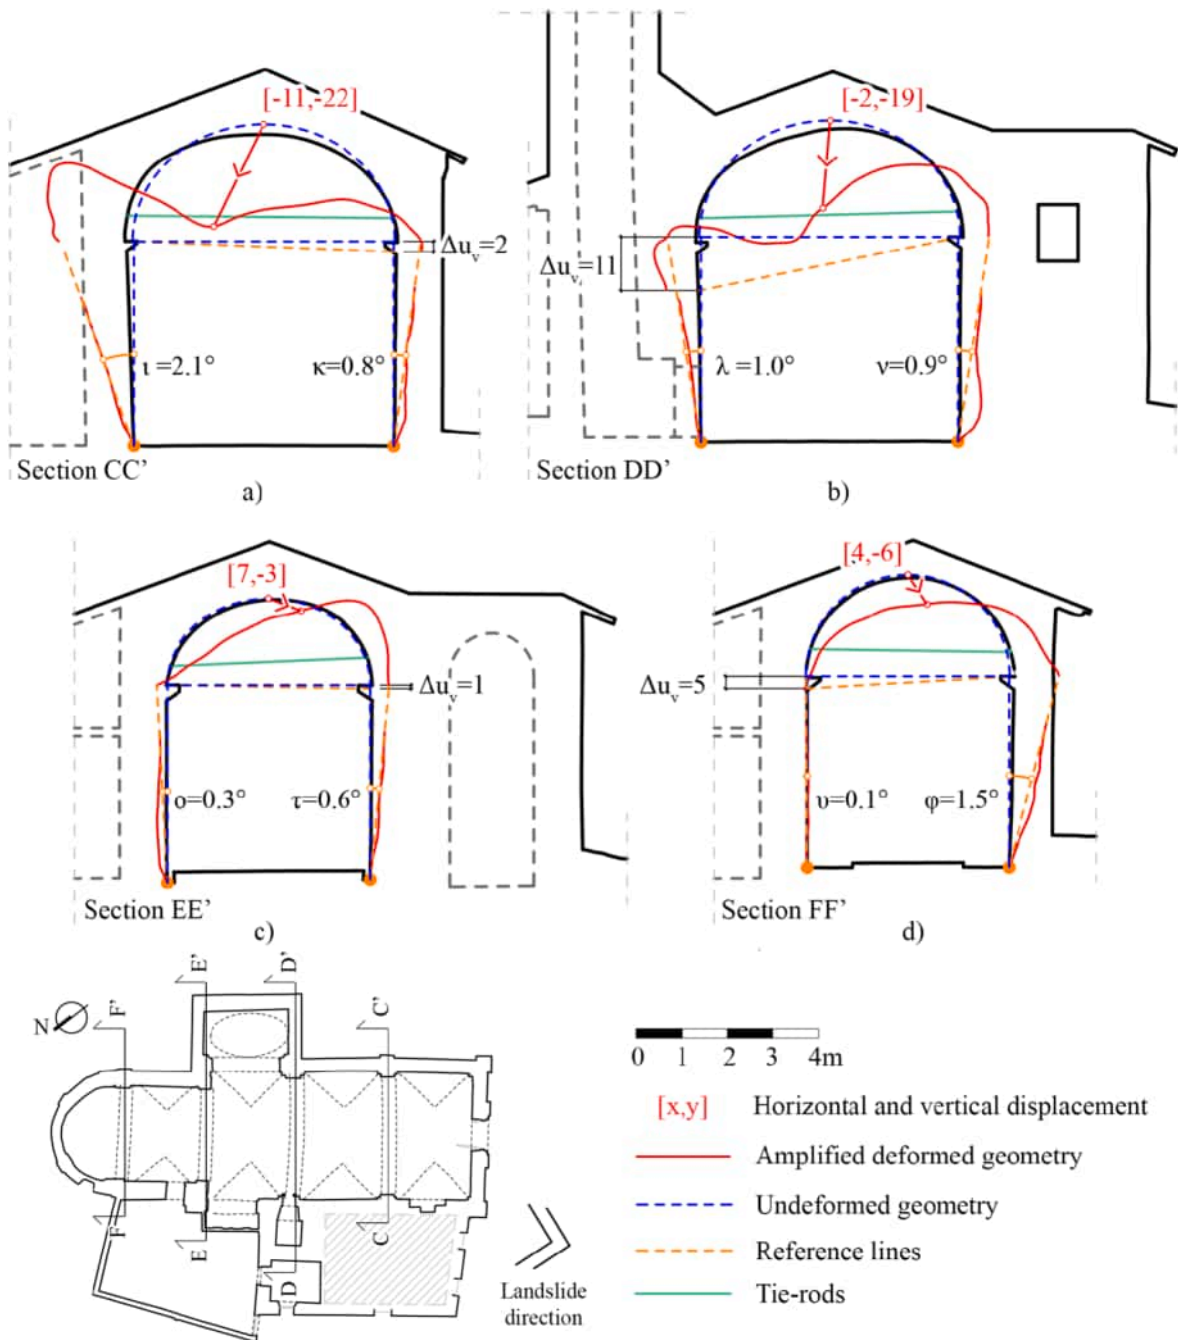
Fig. 7. Deformation analysis of the transverse sections of San Carlo Borromeo church: a) section CC', b) section DD', c) section EE', d) section FF'. (Displacements at the arch springings Δu_v , shown in cm; deformed geometry amplified by 10 times).

The deformation analysis of the transverse sections allowed different deformation phenomena to be identified. First, in sections CC' (Fig. 7a) and DD' (Fig. 7b), both the longitudinal walls were found to present a significant out-of-plumb towards the exterior of the building. Differently, in section EE' (Fig. 7c) and FF' (Fig. 7d), only the right longitudinal wall was observed to lean towards the exterior. Second, the arches of the nave (section CC' and DD' in Fig. 7a-b, respectively) appear to be the most deformed ones, as they exhibit a vertical displacement at the crown that is significantly larger than that of the arches of the apse and presbytery (sections EE'

and FF' in Fig. 7c-d, respectively). This vertical displacement is consistent with the deflection of the barrel vault measured in the longitudinal sections (about 20 cm). Third, the left springing of the arches of sections DD' (Fig. 7b) and FF' (Fig. 7d) settled vertically with respect to the right springing. The largest settlement was observed in correspondence of the belltower (11 cm, see section DD' in Fig. 7b), while a smaller settlement of about 5 cm was found between apse and presbytery (5 cm, see section FF' in Fig. 7d). These vertical settlements suggest the occurrence of a differential foundation settlement between the left and the right side of the church in the area between the apse and the belltower. Such a settlement is confirmed by the significant inclination (downwards to the left) of the tie-rods of sections DD' and EE'. The absence of a significant vertical displacement at the springings of the arch in section EE' does not contrast with the occurrence of the abovementioned differential foundation settlement, as the original springings of this arch were restored over time and, thus, potential movements occurred in the past may have been hidden.

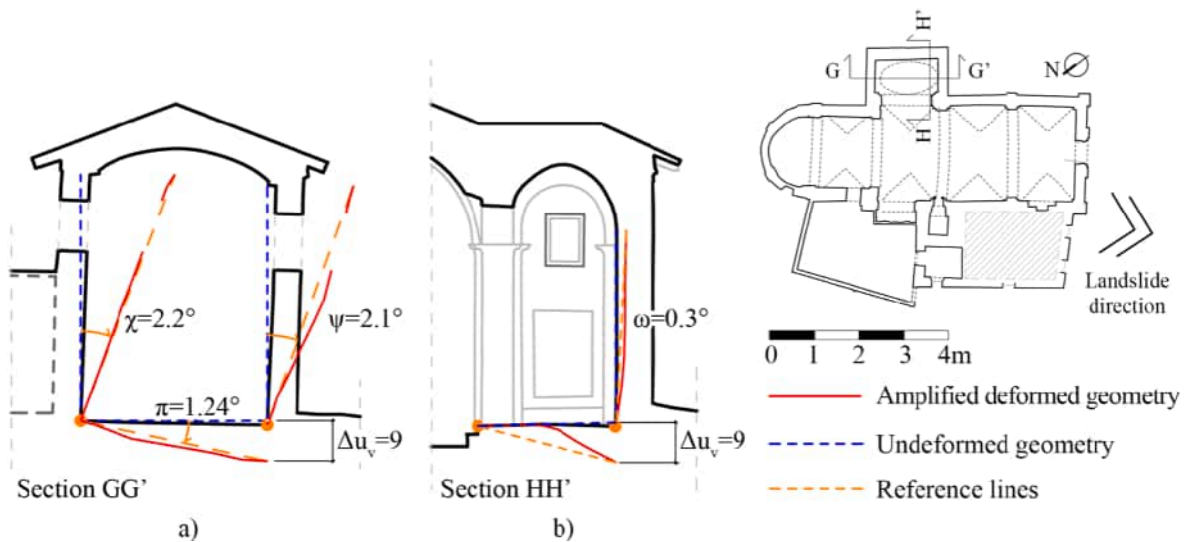
Fig. 9. Deformation analysis of the right chapel of San Carlo Borromeo church: a) section GG', b) section HH'. (Vertical displacements of the floor Δu_v , shown in cm; deformed geometry amplified by 10 times).

The deformation analysis of the right chapel of San Carlo Borromeo church is presented in Fig. 9. The analysis of section GG' (Fig. 9a) shows a rotation of both walls and floor in the direction of the landslide. The rotation of the floor ($\pi = 1.24^\circ$) corresponds to a vertical displacement of 9 cm and is in full accordance with the settlement of the floor detected in section HH' (9 cm, see Fig. 9b). This outcome clearly indicates that the right chapel experienced a settlement of about 9 cm in correspondence of the southern corner.

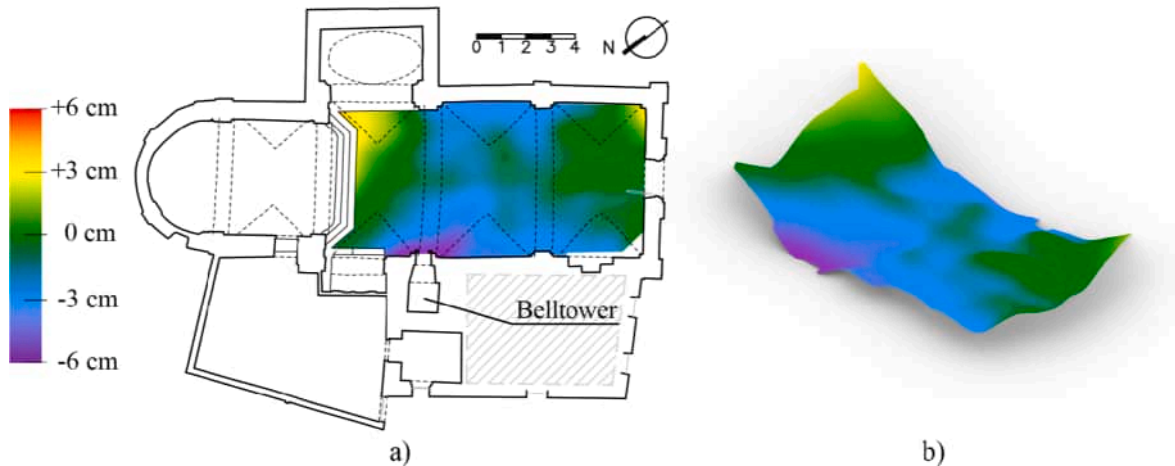
Fig. 11. Displacement analysis of the floor of the nave (represented in terms of out-of-plane displacements): a) plan; b) amplified 3D representation.

Fig. 11 shows the results of the above-described procedure. A localized settlement can be observed in correspondence of the belltower, in good agreement with the vertical displacement observed at the left springing of the transverse arch in section DD'. The smaller vertical displacement detected in the floor (6 cm) with respect to the arch (11 cm) can be explained by the fact that the floor was refurbished in the mid twelfth century.

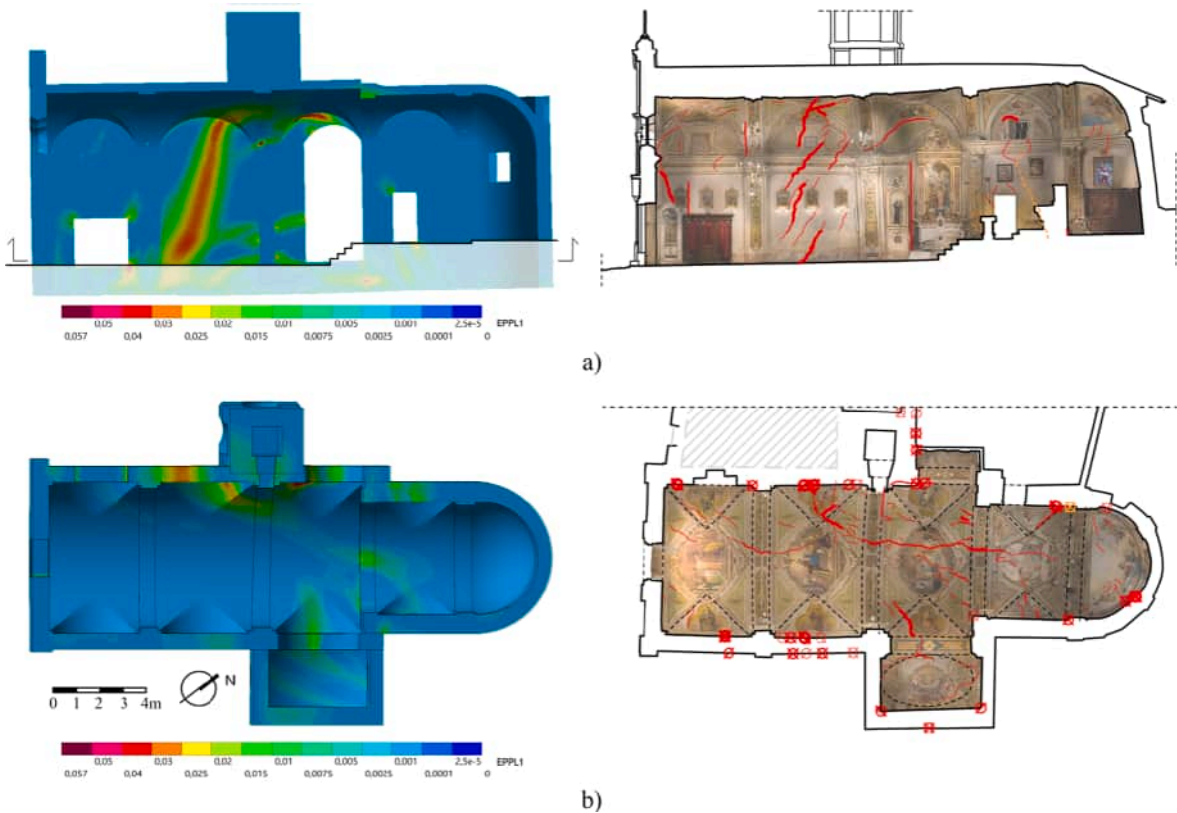
Fig. 18. Comparison between FE results (in terms of maximum principal plastic strain, on the left) and crack pattern surveyed on site (on the right): a) section AA' (left longitudinal wall), b) plan (vaults and walls).

Fig. 18 and Fig. 19 provide a comparison between the damage predicted numerically and the crack patterns and deformations surveyed on site. The numerical model accurately reproduced the cracks in the walls, in particular the large diagonal cracks observed in the left longitudinal wall in the second bay behind the façade (Fig. 18a and Fig. 19a). The occurrence of the damage in the form of widespread plastic deformations instead of a series of well-defined cracks (as observed in the real building) is simply due to the constitutive model adopted for masonry. Since it is perfectly elastoplastic and does not include softening, it is not able to reproduce distinct cracks. As for the damage in the right longitudinal walls, the numerical model correctly predicted the occurrence of a vertical crack in the apse and diagonal cracks in the second bay of the nave behind the façade (compare Fig. 5b and Fig. 17). However, the low values of maximum principal plastic strain indicate that the severity of the real damage was underestimated. The cracking pattern

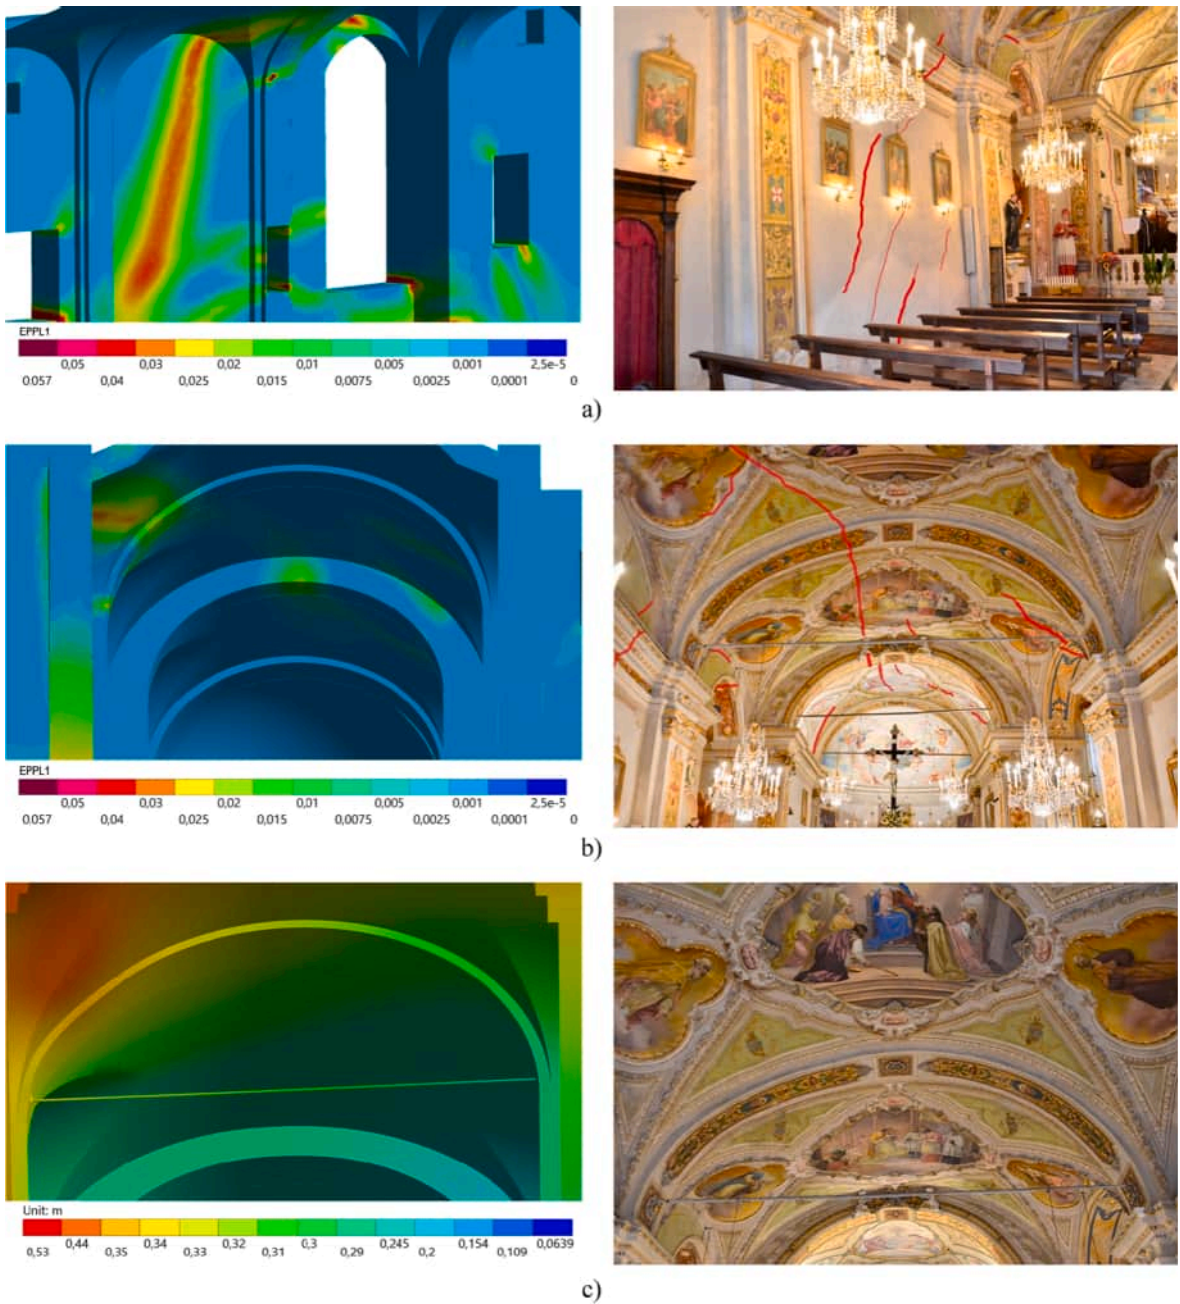
Fig. 19. Comparison between FE results [in terms of maximum principal plastic strain (a-b) or total displacement (c), on the left] and crack patterns and deformations surveyed on site (on the right): a) cracks in the left longitudinal wall, b) cracks in the vaults of the nave and presbytery, c) deformation of the second transverse arch behind the façade.

affecting the vaults of nave and presbytery and the cracks at mid-span of the arches separating nave and lateral chapels were also accurately simulated by the numerical model (see Fig. 18b and Fig. 19b). Lastly, the significant deformation and vertical settlement of the left springing of the second transverse arch behind the façade were accurately predicted (Fig. 19c).
