# Engineering Failure Analysis

## Combined use of deformation and structural analysis for the structural damage assessment of heritage buildings: A case study in the Liguria region (Italy)

Giulio Lucio Sergio Sacco, Chiara Ferrero<sup>\*</sup>, Carlo Battini, Chiara Calderini

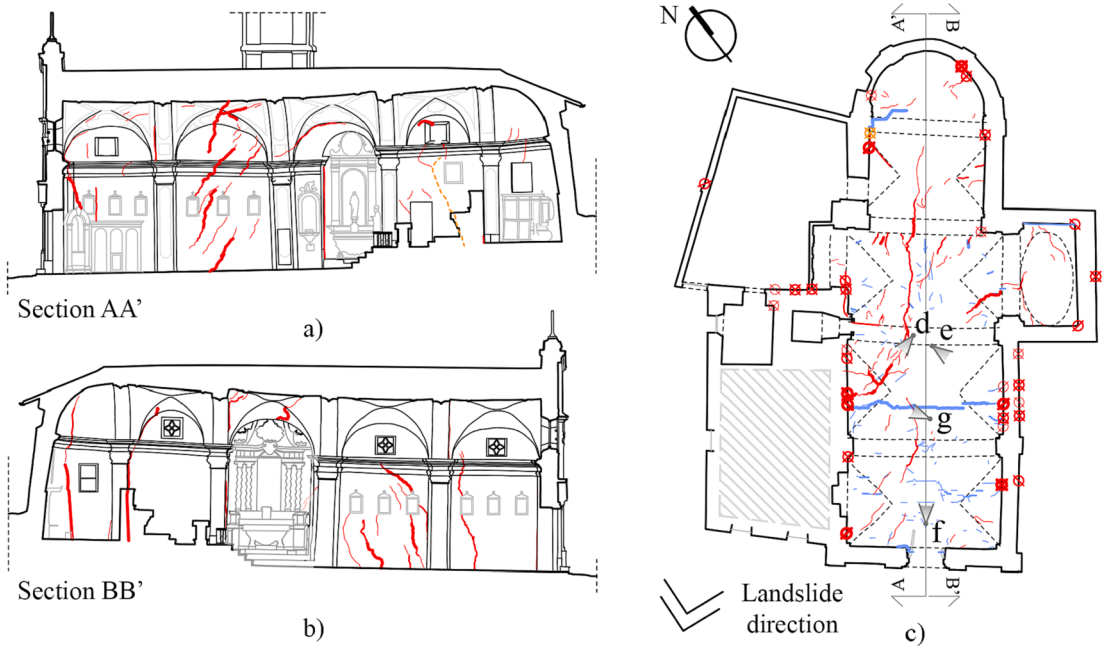
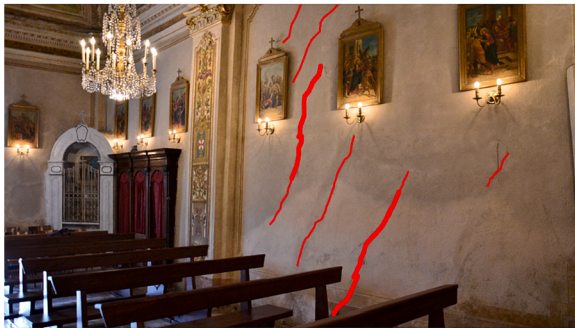
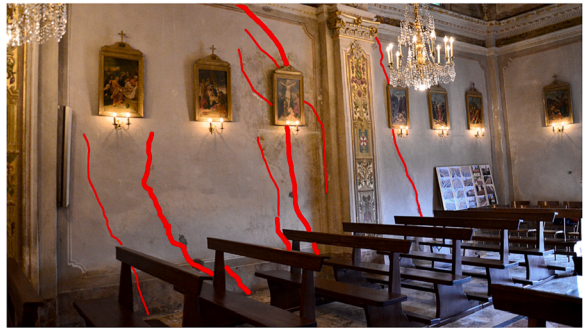
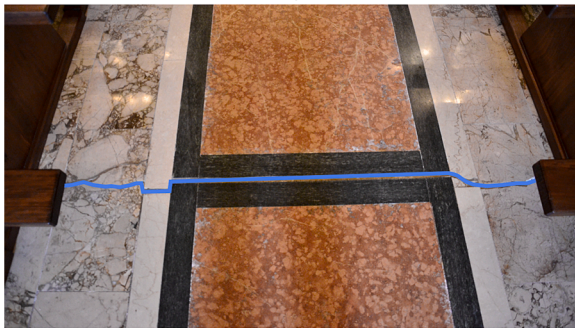
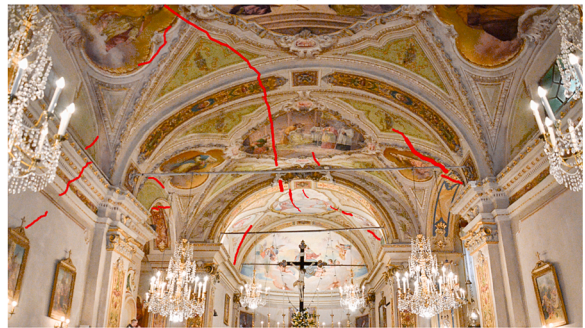
The crack patterns surveyed in San Carlo Borromeo church are presented in plan and elevation in Fig. 5a-b-c. The cracks were classified according to three levels of width: (i) thin for a width up to 1 mm (the latter included), (ii) medium for a width between 1 and 5 mm, and (iii) large for a width equal or larger than 5 mm. The most representative damages are illustrated in Fig. 5d-e-f-g. In 2019, the church underwent a restoration that partially hid the damage on the exteriors. For this reason, the crack patterns observed by the authors in 2020 were integrated with those reported in [8], which date back to 2018.

Severe and extensive damage was observed in the walls. In the nave, the most significant damage was detected in the second bay behind the façade. In this bay, the left (north-western) longitudinal wall is affected by a series of medium to large diagonal cracks progressing upwards towards the apse (see Fig. 5a-d). One of these cracks develops from the level of the ground. Similarly, the right (south-eastern) longitudinal wall exhibits a series of medium to large diagonal cracks propagating from the level of the floor and developing upwards towards the apse (Fig. 5b-e). In addition to these cracking patterns, vertical or slightly inclined cracks developing upwards from the level of the ground are observed in the right longitudinal walls of presbytery, apse, and first bay of the nave behind the façade (see Fig. 5b). Lastly, two large cracks are present in the left longitudinal walls, one located in the first bay behind the façade and the other in the presbytery (Fig. 5a). Both cracks are diagonal and progress upwards towards the façade. The crack in the presbytery was repointed before 2018 and no sign of partial reopening was observed in either 2018 or 2020.

Severe damage was observed also in the floor. In the second bay behind the façade, a large crack (about 12 mm wide) cuts the floor of the entire nave, propagating transversally between the longitudinal walls (see blue line in Fig. 5c-f). This crack is in continuity with the cracks affecting the longitudinal walls. Thin to medium cracks, oriented perpendicular to the direction of the landslide acting in the area, were also observed in the floor of the first bay and the northernmost part of the right chapel (see blue lines in Fig. 5c).

Differently from walls and floor, arches and vaults do not exhibit severe cracking (see Fig. 5c). A thin to medium longitudinal crack, oriented in same direction as the landslide, cuts the barrel vaults of nave and presbytery approximately at mid-span (Fig. 5c-g). This crack changes direction while progressing towards the left longitudinal wall of the nave on one side and the wall of the presbytery on the other side. Thin cracks with a slight concentric pattern are also detected around the belltower (Fig. 5c). Lastly, very thin diagonal cracks are widespread in the nave, presbytery, and right chapel.

**Fig. 5.** Damage survey of San Carlo Borromeo church in Cassinengo: a) crack pattern in plan (the direction of the slow-moving landslide acting in the area is indicated with an arrow), b) crack pattern in elevation (section AA', left longitudinal wall), c) crack pattern in elevation (section BB', right longitudinal wall), d-e) diagonal cracks in the left (d) and right (e) longitudinal walls of the nave (second bay behind the façade), e) large crack in the floor of the nave, f) cracks in arches and vaults.

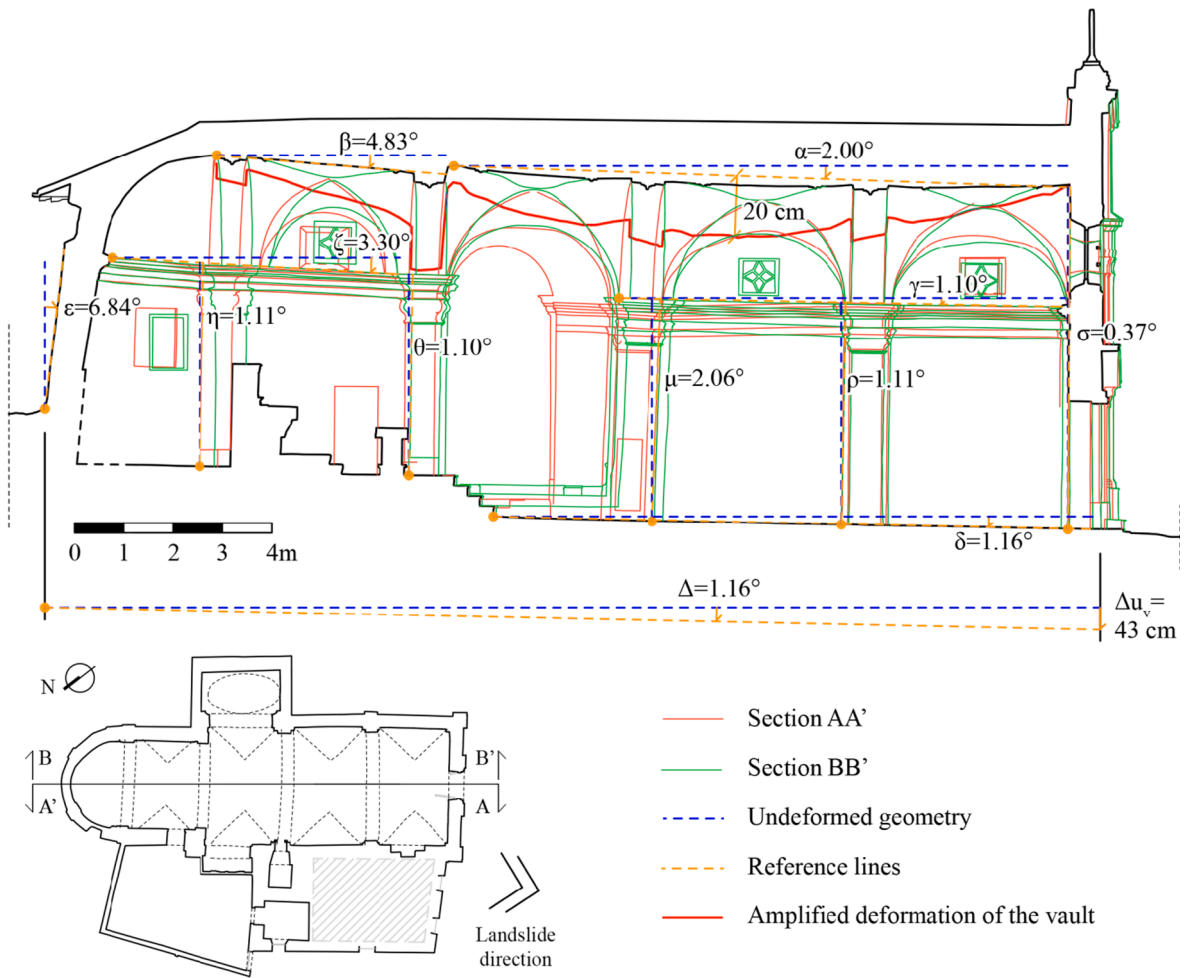
The deformation analysis of the longitudinal sections is shown in Fig. 6. Walls, pilasters, vaults, mouldings, and floors were chosen as the architectural elements to be analysed. For each element, the deformation was estimated by choosing a reference pole of rotation (orange dot in Fig. 6) and a reference line representing the undeformed reference configuration (blue dashed line in Fig. 6) and measuring the rotation between the reference geometry and the surveyed one. The reference line was assumed to be vertical for walls and pilasters and horizontal for floor and mouldings. In the case of the vault of the nave, which exhibits a significant deformation (solid red line in Fig. 6, amplified by ten times), the rotation was measured between the horizontal reference line and a line connecting the two extremities of the vault (orange dashed line in Fig. 6). As shown in Fig. 6, all the architectural elements analysed exhibit a rotation towards valley, in the direction of the slow-moving landslide. This outcome clearly indicates that the entire church experienced a

Fig. 6. Deformation analysis of the longitudinal sections of San Carlo Borromeo church: superimposition of sections AA' and BB'. (Deformed geometry of the vault amplified by 10 times).

global rotation in this direction. The most significant rotations were observed in the apse and presbytery. The vault of the presbytery, the apse wall, and the mouldings were found to be rotated with respect to the vertical by about 4.83° (see angle  $\beta$  in Fig. 6), 6.84° (angle  $\epsilon$ ), and 3.30° (angle  $\zeta$ ), respectively. In the nave, the floor and the mouldings show a smaller rotation of 1.16° (angle  $\delta$ ) and 1.10° (angle  $\gamma$ ), respectively, while the barrel vault exhibits a rotation of 2.00° (angle  $\alpha$ ) in addition to a deflection of about 20 cm in the centre of the second bay (see Fig. 6). All the pilasters present a rotation of about 1.1° except for the second one from the façade, which shows a larger rotation (2.06°, angle  $\mu$ ). No significant rotations were detected in the façade. The larger rotations measured in the presbytery and apse compared to the nave can be explained considering that the presbytery and the apse were built before the nave and, thus, they may have experienced deformations for a longer period of time (see Section 2.1). Due to the uncertainties about the historical information, the rotation of the floor of the nave was conservatively chosen to represent the overall rotation experienced by the church. By applying a rotation of 1.16° to the whole church and placing the rotation pole at the exterior of the apse (see angle  $\Delta$  in Fig. 6), the vertical displacement between the apse and the façade ( $\Delta u_v$ ) can be estimated at about 43 cm.

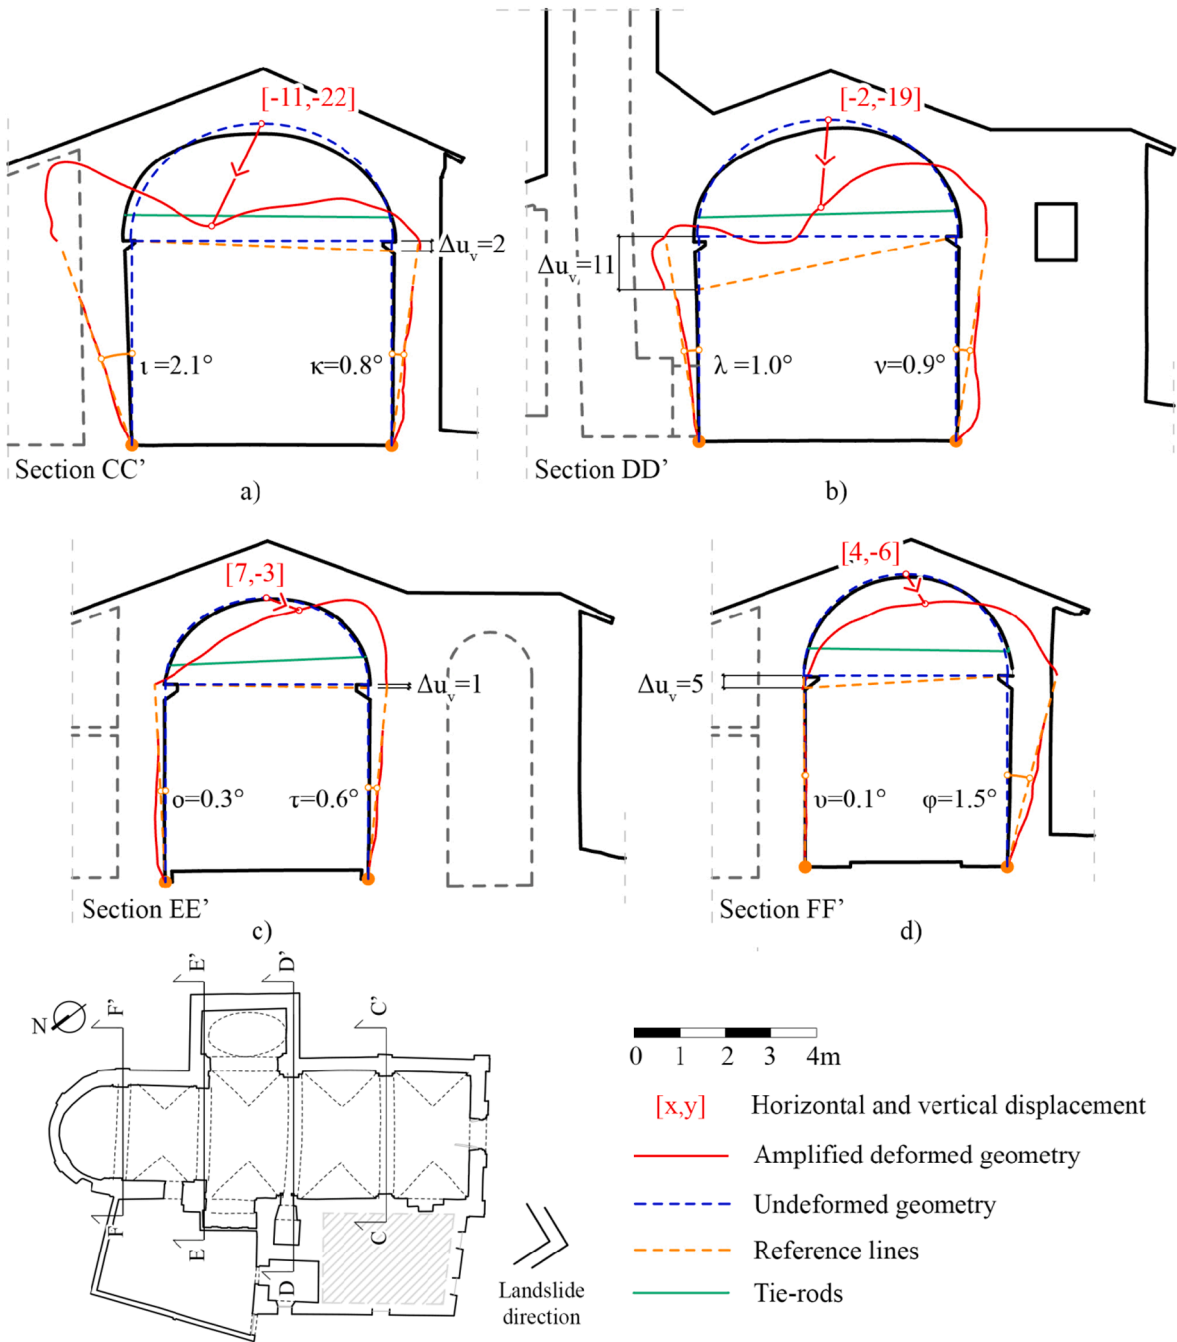
Fig. 7. Deformation analysis of the transverse sections of San Carlo Borromeo church: a) section CC', b) section DD', c) section EE', d) section FF'. (Displacements at the arch springings  $\Delta u_v$ , shown in cm; deformed geometry amplified by 10 times).

The deformation analysis of the transverse sections allowed different deformation phenomena to be identified. First, in sections CC' (Fig. 7a) and DD' (Fig. 7b), both the longitudinal walls were found to present a significant out-of-plumb towards the exterior of the building. Differently, in section EE' (Fig. 7c) and FF' (Fig. 7d), only the right longitudinal wall was observed to lean towards the exterior. Second, the arches of the nave (section CC' and DD' in Fig. 7a-b, respectively) appear to be the most deformed ones, as they exhibit a vertical displacement at the crown that is significantly larger than that of the arches of the apse and presbytery (sections EE'

and FF' in Fig. 7c-d, respectively). This vertical displacement is consistent with the deflection of the barrel vault measured in the longitudinal sections (about 20 cm). Third, the left springing of the arches of sections DD' (Fig. 7b) and FF' (Fig. 7d) settled vertically with respect to the right springing. The largest settlement was observed in correspondence of the belltower (11 cm, see section DD' in Fig. 7b), while a smaller settlement of about 5 cm was found between apse and presbytery (5 cm, see section FF' in Fig. 7d). These vertical settlements suggest the occurrence of a differential foundation settlement between the left and the right side of the church in the area between the apse and the belltower. Such a settlement is confirmed by the significant inclination (downwards to the left) of the tie-rods of sections DD' and EE'. The absence of a significant vertical displacement at the springings of the arch in section EE' does not contrast with the occurrence of the abovementioned differential foundation settlement, as the original springings of this arch were restored over time and, thus, potential movements occurred in the past may have been hidden.

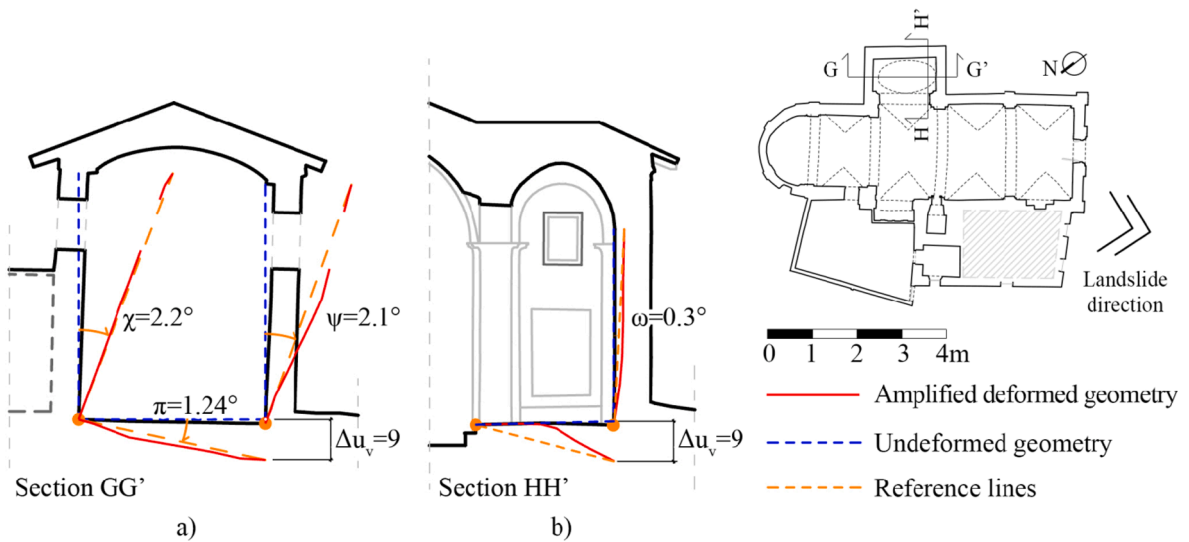
**Fig. 9.** Deformation analysis of the right chapel of San Carlo Borromeo church: a) section GG', b) section HH'. (Vertical displacements of the floor  $\Delta u_v$ , shown in cm; deformed geometry amplified by 10 times).

The deformation analysis of the right chapel of San Carlo Borromeo church is presented in Fig. 9. The analysis of section GG' (Fig. 9a) shows a rotation of both walls and floor in the direction of the landslide. The rotation of the floor ( $\pi = 1.24^\circ$ ) corresponds to a vertical displacement of 9 cm and is in full accordance with the settlement of the floor detected in section HH' (9 cm, see Fig. 9b). This outcome clearly indicates that the right chapel experienced a settlement of about 9 cm in correspondence of the southern corner.

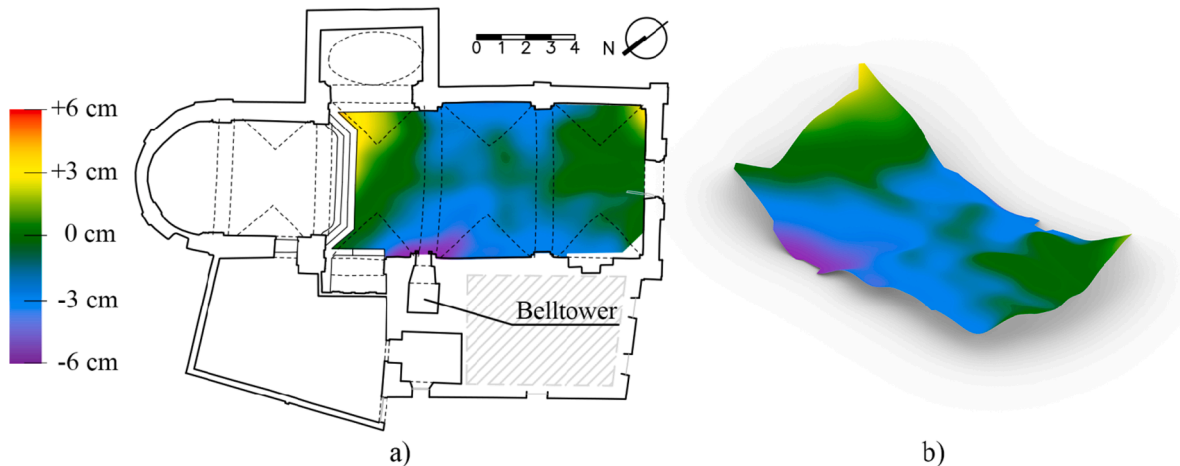
**Fig. 11.** Displacement analysis of the floor of the nave (represented in terms of out-of-plane displacements): a) plan; b) amplified 3D representation.

Fig. 11 shows the results of the above-described procedure. A localized settlement can be observed in correspondence of the belltower, in good agreement with the vertical displacement observed at the left springing of the transverse arch in section DD'. The smaller vertical displacement detected in the floor (6 cm) with respect to the arch (11 cm) can be explained by the fact that the floor was refurbished in the mid twelfth century.

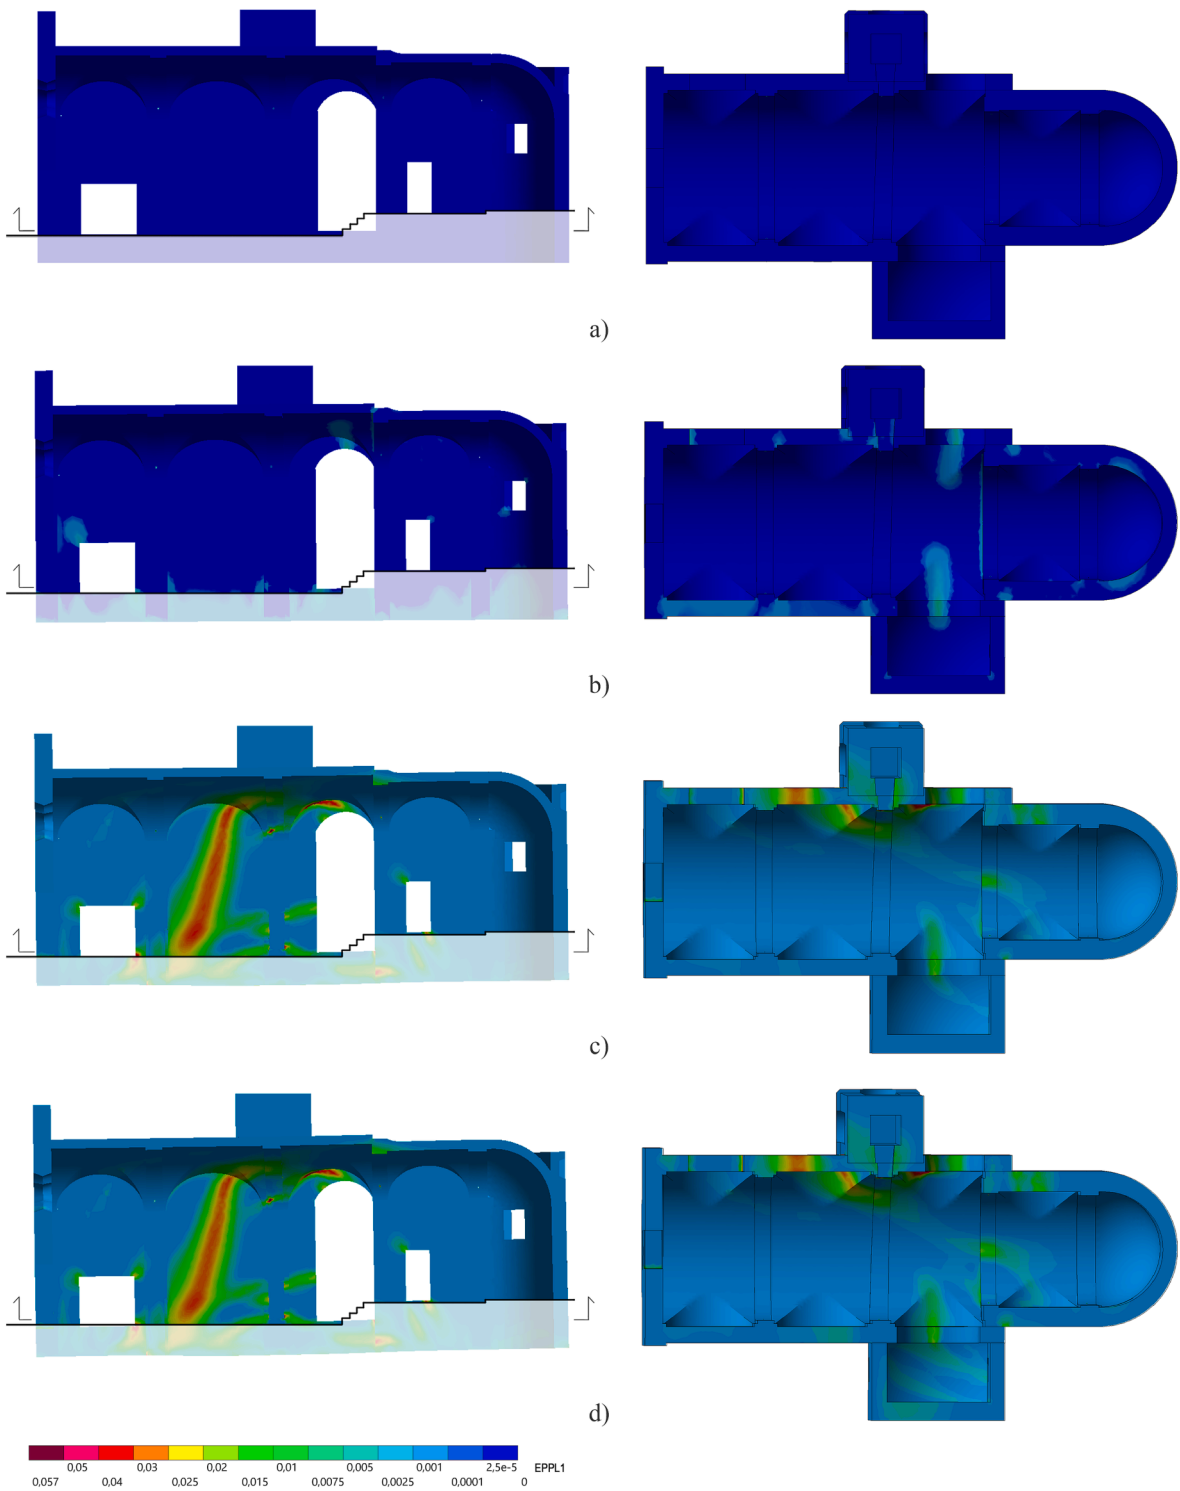
**Fig. 16.** Maximum principal plastic strain obtained at the end of each step of the sequence of loads and displacement fields identified in Fig. 15: a) step 0, b) step 1, c) step2, d) step 3. On the left: left side of the church (section AA’); on the right, plan (vaults and base of the walls, see the cutting plane line indicated on the left).

Fig. 16 shows the results obtained at the end of each step of application of the displacement fields in terms of maximum principal plastic strain, which provides an indication of the crack formation. The results are presented in elevation for the left side of the church (section AA'), which is the most representative (see Fig. 16 on the left), and in plan for the vaults and the base of the walls (see Fig. 16 on the right). The plan is obtained by cutting the numerical model approximately at the level of the floor of the nave (the cutting plane line is shown in Fig. 16 on the left). The application of the self-weight (step 0) did not produce any damage (Fig. 16a), while the application of the first third of the landslide-induced global displacements (step 1) resulted in limited damage (Fig. 16b), mostly localized at the base of the longitudinal walls and at mid-span of the arches that separate the nave from the lateral chapels (third bay behind the façade). As shown in Fig. 16c, the application of the settlement of the left side of the building and the second third of the global displacements (step 2) produced a significant worsening of the damage state of the church. Extensive cracks appeared in the left longitudinal wall as well as in the vaults of nave, presbytery, and right chapel. Conversely, the application of the settlement of the right chapel and the last third of the global displacements (step 3, Fig. 16c) did not significantly worsen the damage level, except in the right chapel, as expected, where further damage occurred in both walls and vaults. A vertical and diagonal crack also appeared in the right

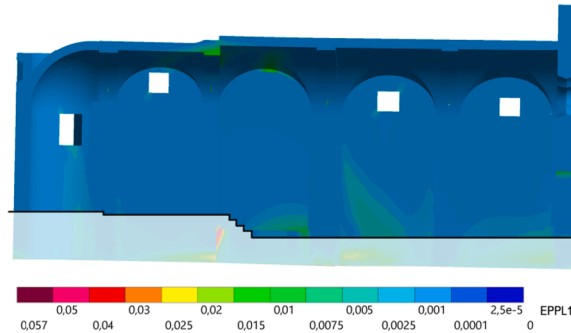
Fig. 17. Maximum principal plastic strain obtained in the right side of the church (section BB') at the end of the sequence of application of the loads and displacement fields identified in Fig. 15 (end of step 3).

longitudinal wall, respectively in the apse and the second bay behind the façade (Fig. 17).

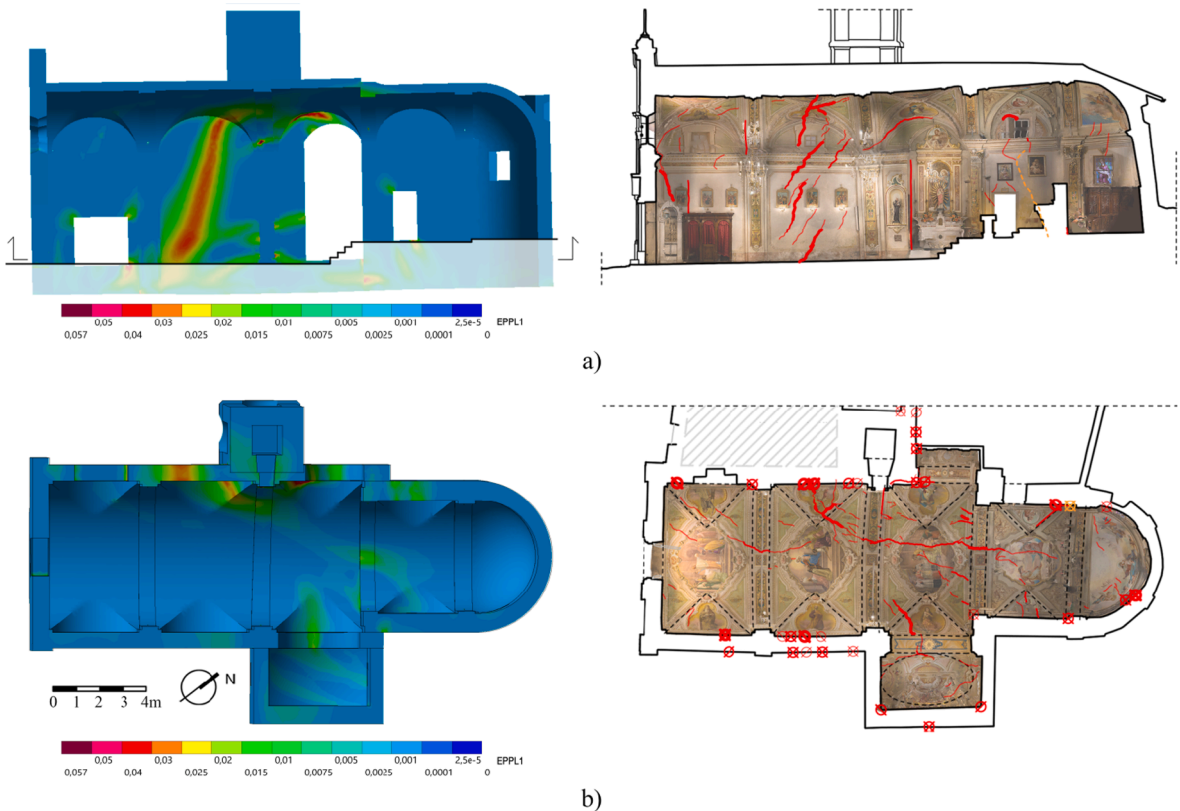
Fig. 18. Comparison between FE results (in terms of maximum principal plastic strain, on the left) and crack pattern surveyed on site (on the right): a) section AA' (left longitudinal wall), b) plan (vaults and walls).

Fig. 18 and Fig. 19 provide a comparison between the damage predicted numerically and the crack patterns and deformations surveyed on site. The numerical model accurately reproduced the cracks in the walls, in particular the large diagonal cracks observed in the left longitudinal wall in the second bay behind the façade (Fig. 18a and Fig. 19a). The occurrence of the damage in the form of widespread plastic deformations instead of a series of well-defined cracks (as observed in the real building) is simply due to the constitutive model adopted for masonry. Since it is perfectly elastoplastic and does not include softening, it is not able to reproduce distinct cracks. As for the damage in the right longitudinal walls, the numerical model correctly predicted the occurrence of a vertical crack in the apse and diagonal cracks in the second bay of the nave behind the façade (compare Fig. 5b and Fig. 17). However, the low values of maximum principal plastic strain indicate that the severity of the real damage was underestimated. The cracking pattern

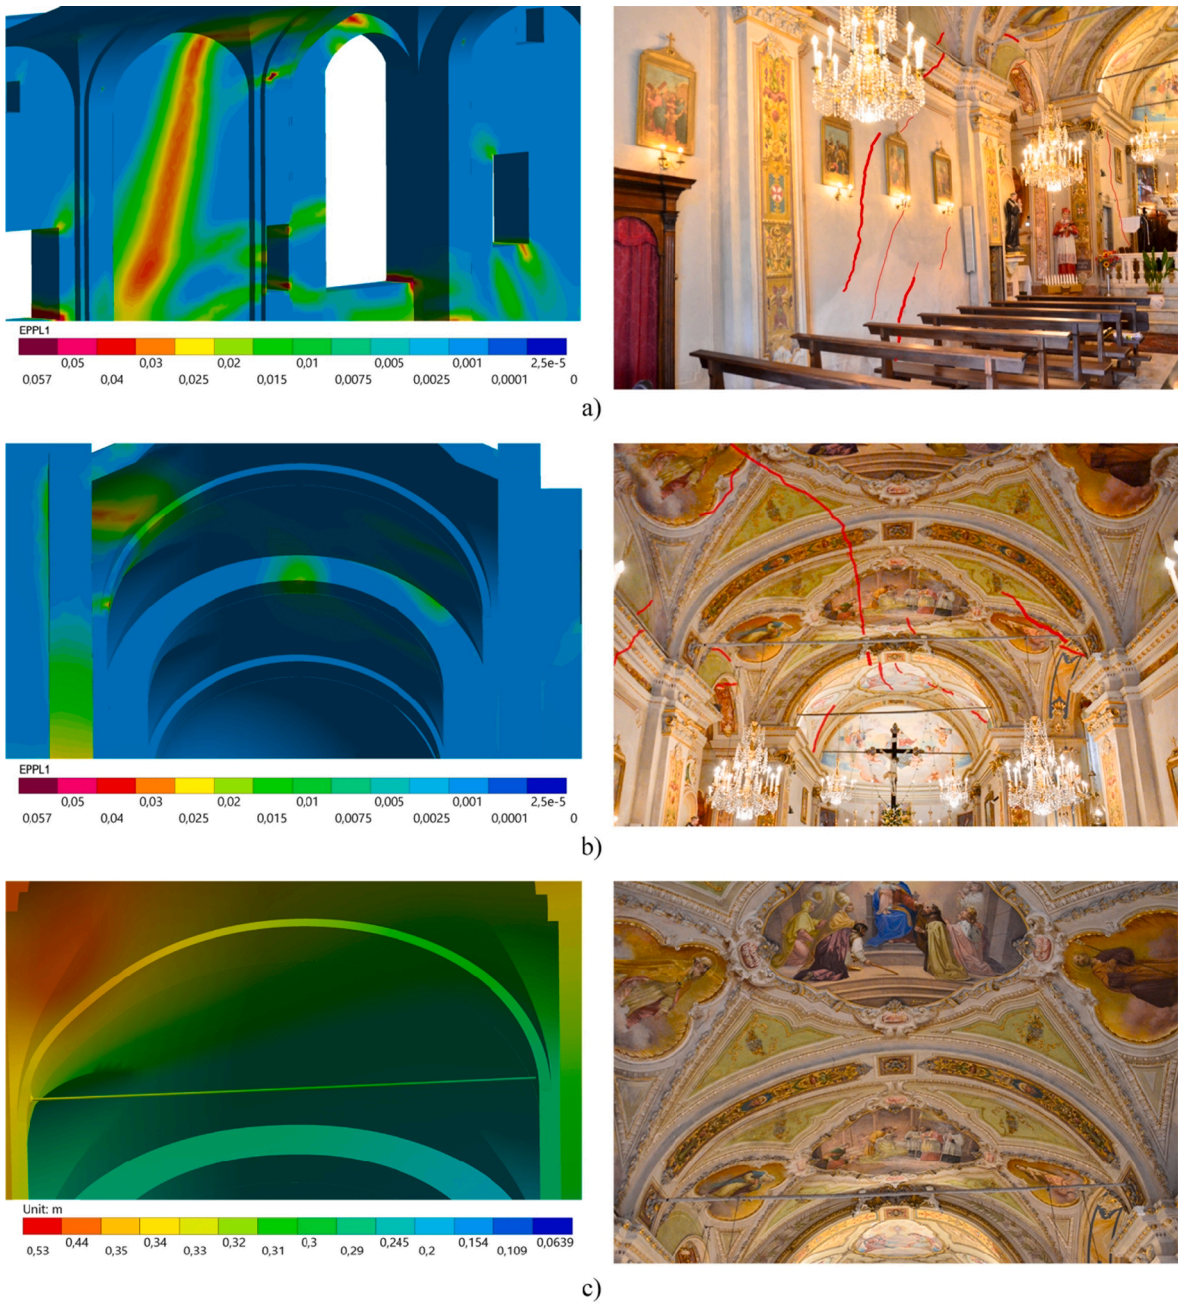
**Fig. 19.** Comparison between FE results [in terms of maximum principal plastic strain (a-b) or total displacement (c), on the left] and crack patterns and deformations surveyed on site (on the right): a) cracks in the left longitudinal wall, b) cracks in the vaults of the nave and presbytery, c) deformation of the second transverse arch behind the façade.

affecting the vaults of nave and presbytery and the cracks at mid-span of the arches separating nave and lateral chapels were also accurately simulated by the numerical model (see Fig. 18b and Fig. 19b). Lastly, the significant deformation and vertical settlement of the left springing of the second transverse arch behind the façade were accurately predicted (Fig. 19c).
