EEHB 2022 Post Prints

The 4th International Conference on
Energy Efficiency in Historic Buildings

Balancing energy efficiency and conservation aspects of Terragni's Casa del Fascio in Como: thermal analysis, energy modelling and intervention proposals

S. Mauri, V. Pracchi

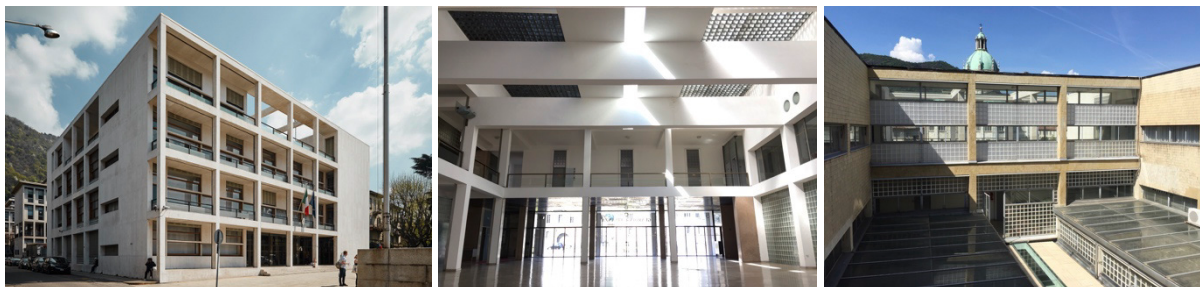
Figure 1. (a) Outside view of the Casa del Fascio. (b, c) Inside view of the *Salone delle Adunate* and courtyard.

The building has four floors with a square plan, and its crux is a large central double height hall called *Salone delle Adunate* (Gatherings room). The gallery on the first floor overlooks this huge space and connects the offices. The second floor follows the distribution system of the first floor: the only difference is that the gallery opens onto the roof of the *Salone delle Adunate*, which is the floor of the inner courtyard, characterised by a skylight in concrete-frame glass blocks crossed in the middle by a walkway. On the top floor the building is divided in two parts by two open galleries: reaching this last floor is only possible by using the secondary staircase, while the other two floors

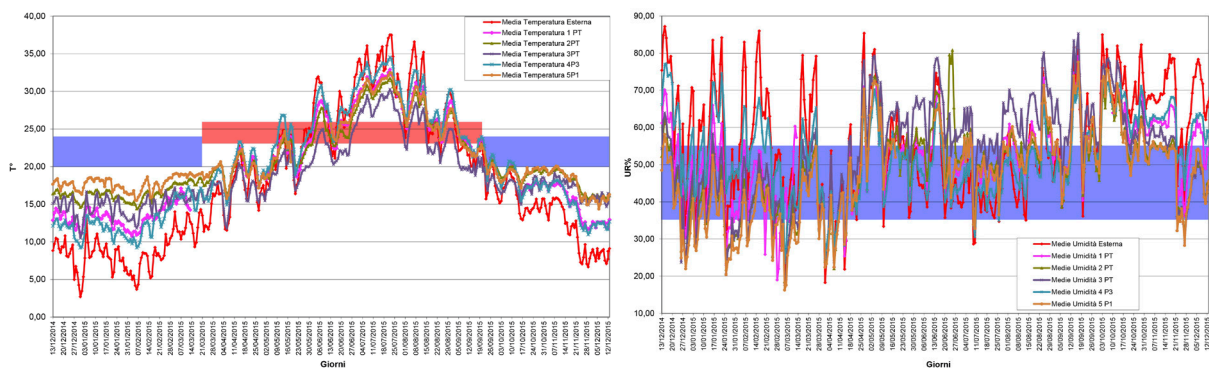
Figure 2. (a) Graph of daily average temperature. (b) Graph of daily average relative humidity.

13th December 2014 and ended on 5th May 2016, for a total of approximately one-and-a-half-year. The monitoring phase showed a strongly oscillating behaviour of both temperature and relative humidity which are the result of the influence of the external climate. By looking at the graph of the daily average temperatures it can be seen that the days in which the values fall into the winter and summer comfort zones (provided by the current standard) are very limited [13]. In winter, the heating system⁹ is only partially able to guarantee comfort conditions: the air temperature inside the rooms seldom reaches 20°C. The summer period turns out to be the most critical because there is no possibility of limiting overheating. The microclimatic probes measured internal temperatures very close to those external: the highest recorded temperature is around 35°C (in July). The graph of daily average relative humidity confirms a strong sensitivity to external variations during the year, which corresponds to a significant fluctuation of the indoor conditions [7]. Generally speaking, the indoor microclimate conditions of Casa del Fascio are far from complying with the standard requirements and the main cause is the use of lightweight construction techniques, typical of the 20th century architecture: as a matter of fact, large windows and thin walls favour a strong heat loss in winter and a considerable solar gain in summer when the external temperature rises.
