## Review

# Infrared Thermography in Photovoltaic Systems: A Review for Maximizing Energy Yield and Long-Term Reliability

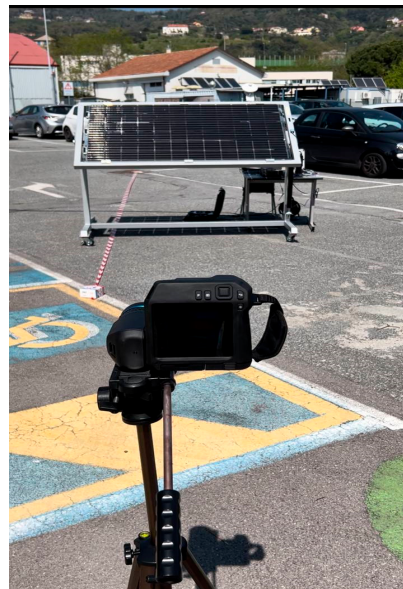
**Figure 8.** Experimental setup at the University of Genova Savona Campus showing the bifacial PV mobile bench oriented at an azimuth angle of +60° facing southwest, with the FLIR thermal camera mounted on a tripod at 6 m.

1005 W m<sup>-2</sup>, and 950 W m<sup>-2</sup>, respectively. Figure 8 shows the experimental setup used during the campaign.

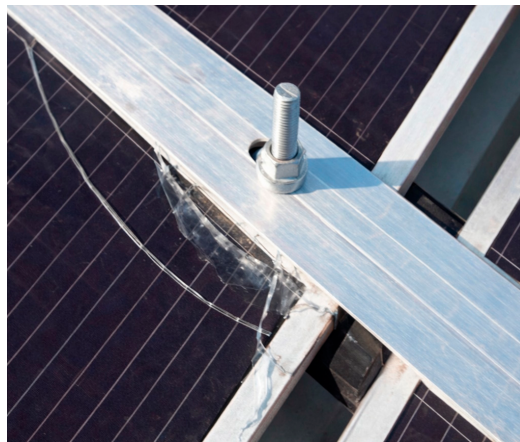
**Figure 10.** Example of glass breakage on a PV module caused by mechanical mounting stress (adapted from [70]).

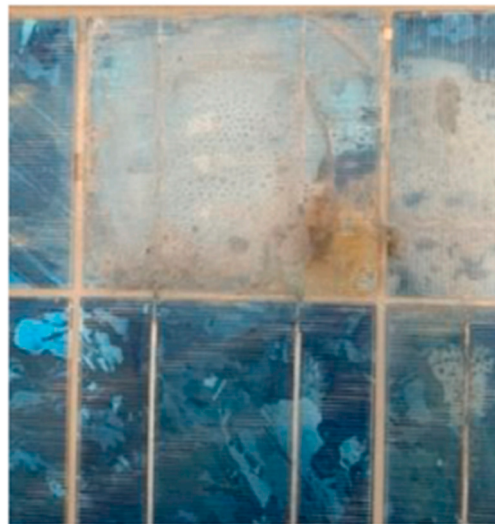
**Figure 14.** Advanced glass corrosion across a PV module surface, showing widespread hazing and opacity caused by environmental exposure. The affected area exhibits reduced transparency and transmission loss, likely due to degradation of anti-reflective coatings and chemical interactions with atmospheric pollutants [74].

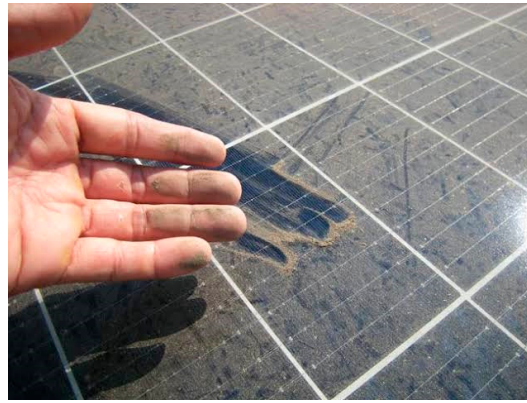
**Figure 16.** Accumulated dust on different PV modules installed in Kuwait, showing varying soiling patterns and intensities.

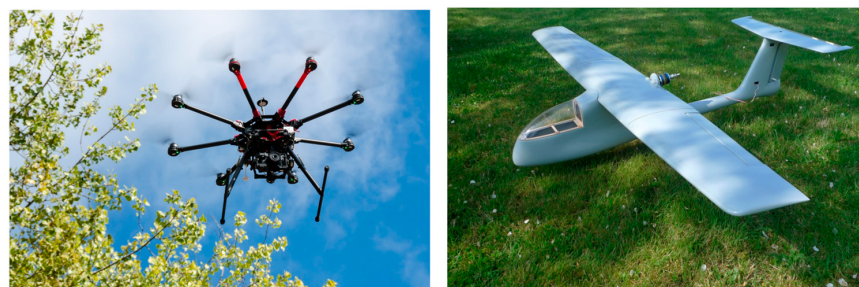
**Figure 21.** UAV types used in PV inspection: (left) multirotor hexacopter ideal for detailed, localized monitoring; (right) fixed wing UAV suitable for long range, large area surveillance [112].
