TRACES OF HISTORY IN THE SEMI-ABANDONED VILLAGES HIT BY AN EARTHQUAKE: ELEMENTS FOR A CONSCIOUS RESTORATION

Daniela Pittaluga

Università degli studi di Genova-Italia

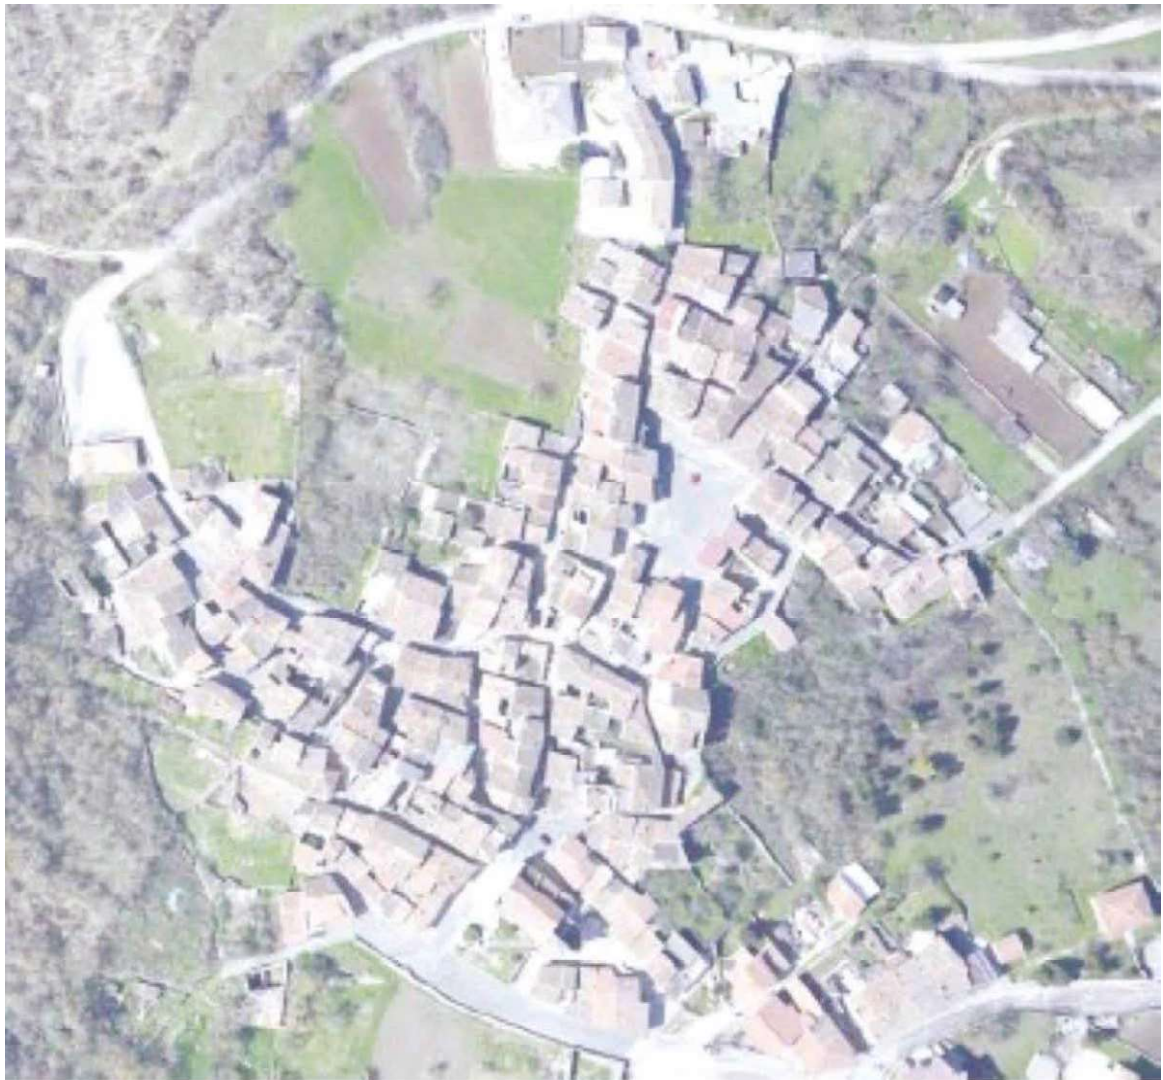
**Aerial view
of Casentino**
(L'Aquila
province,
Italy)
(source:
Carocci et al.
2010).

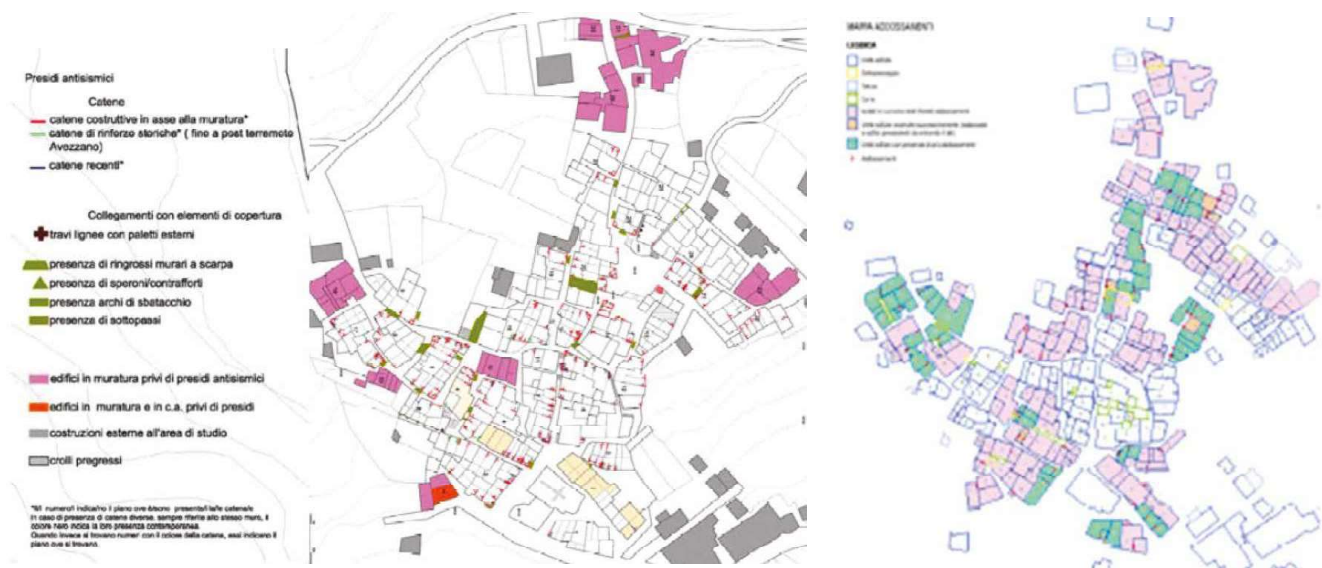
The preliminary organization of the field surveys was carried out on the basis of the basic cartographic documentation available, in particular the regional technical map (CTR, scale 1:5000), integrated with some information acquired from available aerial shots. After the survey of the blocks, the “map of the Building Units (B.U.)” was drawn up (Figs 2 a, 2b).
