Article

Roughness and SEM Analysis of Manual and Ultrasonic Instrumentation over Different Crown Materials for Dental Implants Restorations

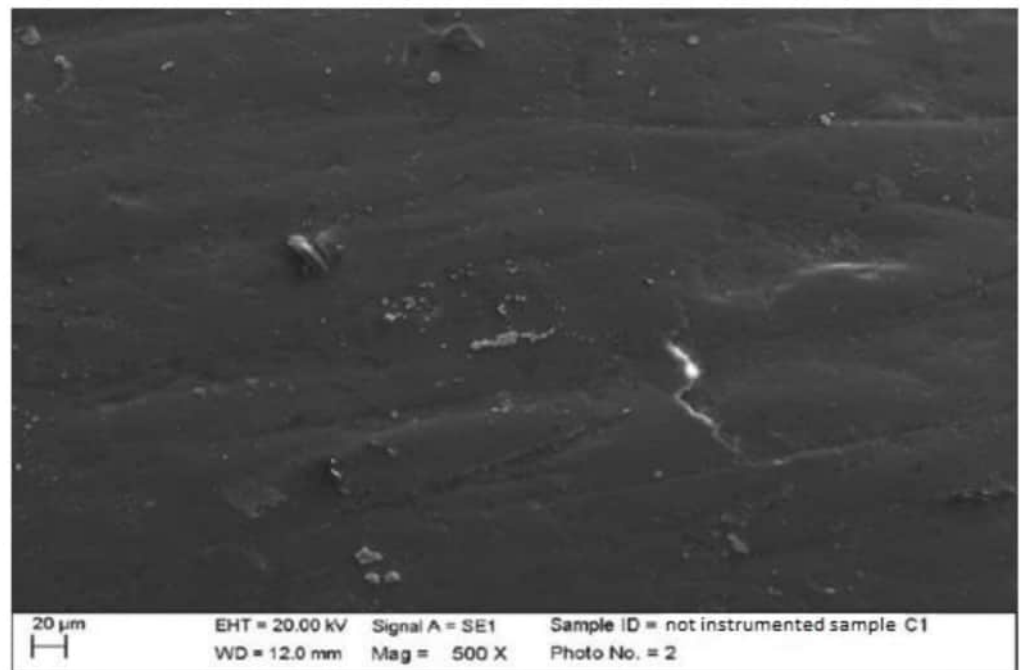
There were processing residues on the composite, but to a lesser extent than on the ceramic, as can be seen in the following images. Some streaks and concavities with clear edges that represent the irregularity of the surface of the prosthetic element were clearly visible in the highest magnifications (500 \times , 2000 \times) (Figure 1). In the second sample, it is possible to notice at the 500 \times magnification the presence of slight surface incisions caused by the tools used for the final polishing of the composite element (Figure 2).

Figure 1. Non-instrumented composite sample C1 (500×).

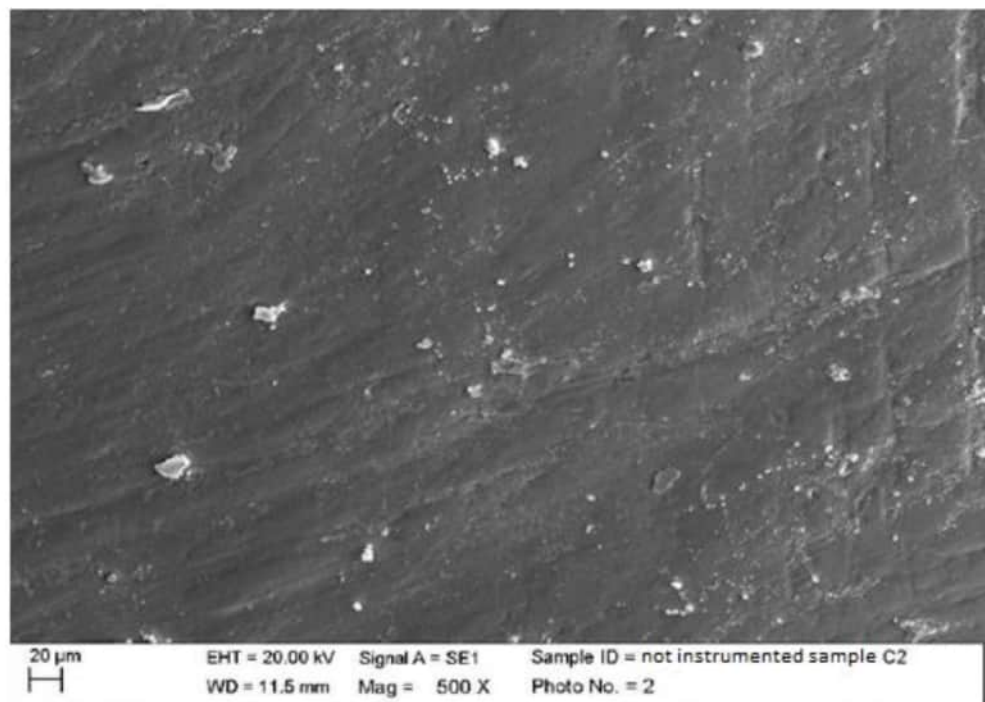
Figure 2. Non-instrumented composite sample C2 (500×).

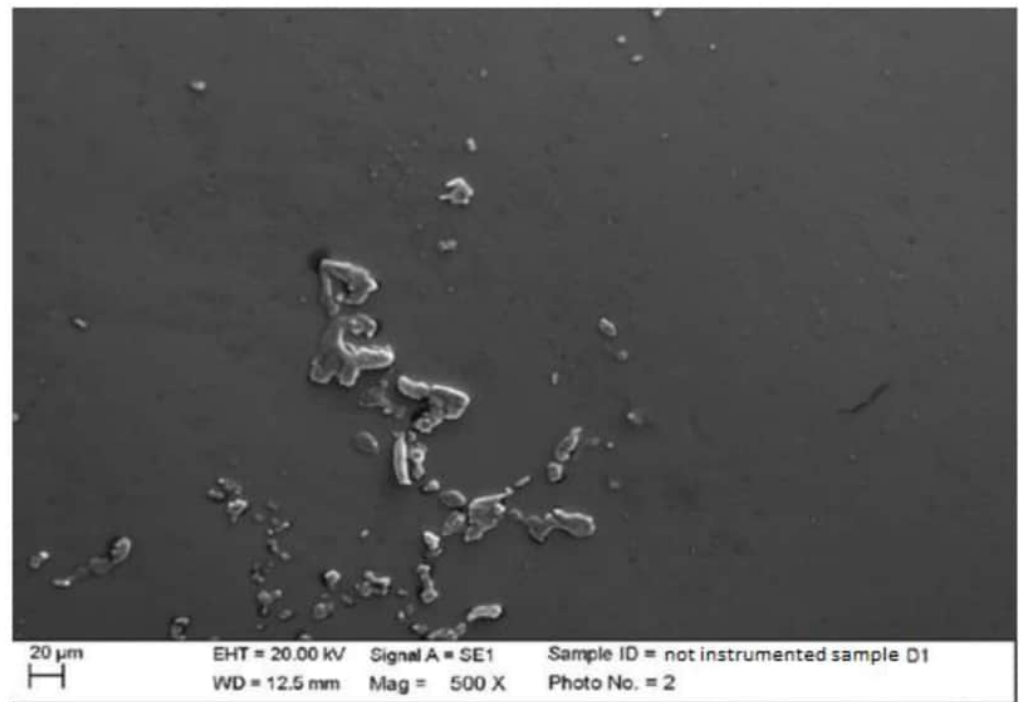
The surface of the lithium disilicate had a very smooth appearance. Processing residues, especially subsurface, were present, but in smaller quantities than the other materials; however, the dimensions of the individual particles were larger (Figure 3).

Figure 3. Non-instrumented disilicate sample D1 (500×).

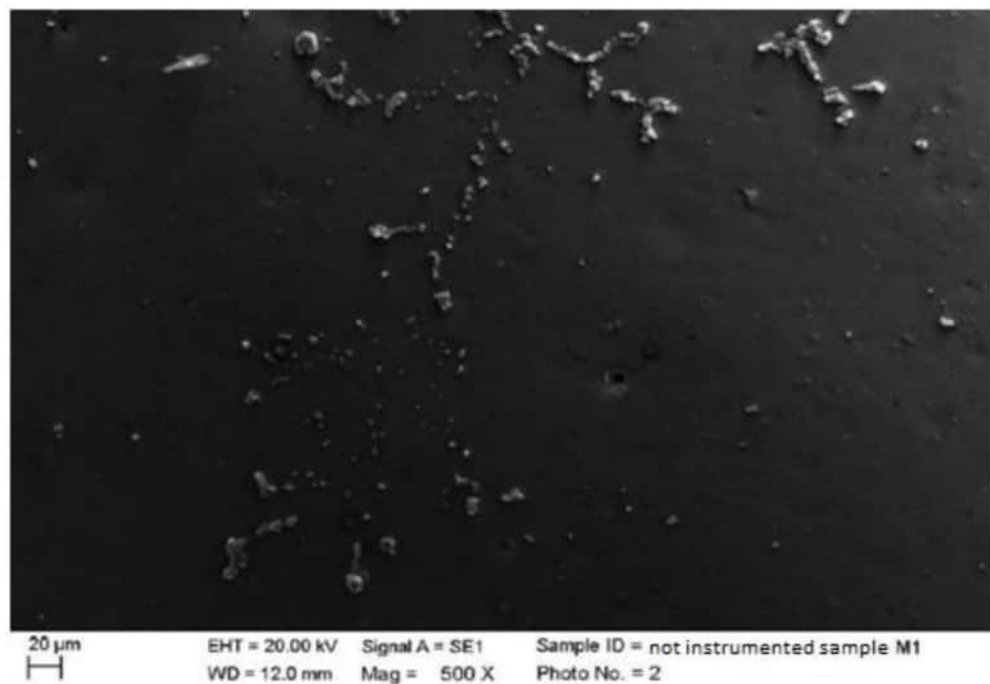
As for the elements made of ceramic material with a metal substructure, we could see, in an increasingly defined manner as the magnification increased (500×), residues from the processing of the material itself. In particular, the residues incorporated within the structure of the material were visible to the maximum degree (2000×) as if they were covered by a thin film. There were also small depressions, which confirmed that the ceramic material was a hard but, at the same time, fragile material (Figure 4).

Figure 4. Non-instrumented ceramic sample M1 (500×).

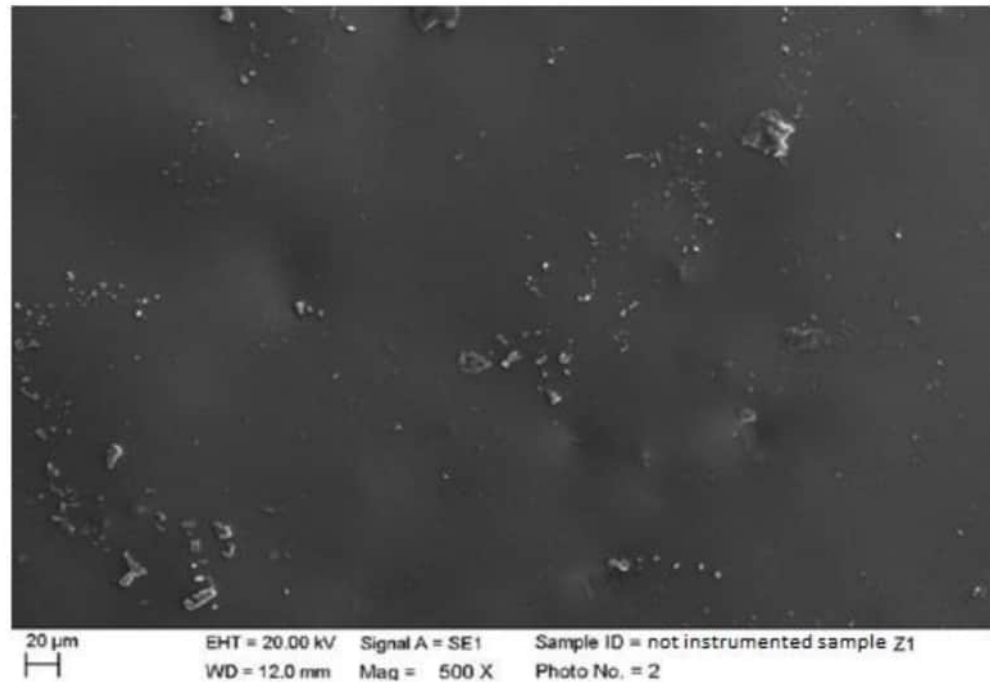
Zirconium, similar to lithium disilicate, had a surface with few processing residues of rather large dimensions. Similar to ceramic, on the other hand, it had a fracture area with clear edges caused by the finishing process of the element and determined by the greater hardness of this material (Figure 5).

Figure 5. Non-instrumented zirconium sample Z1 (500×).

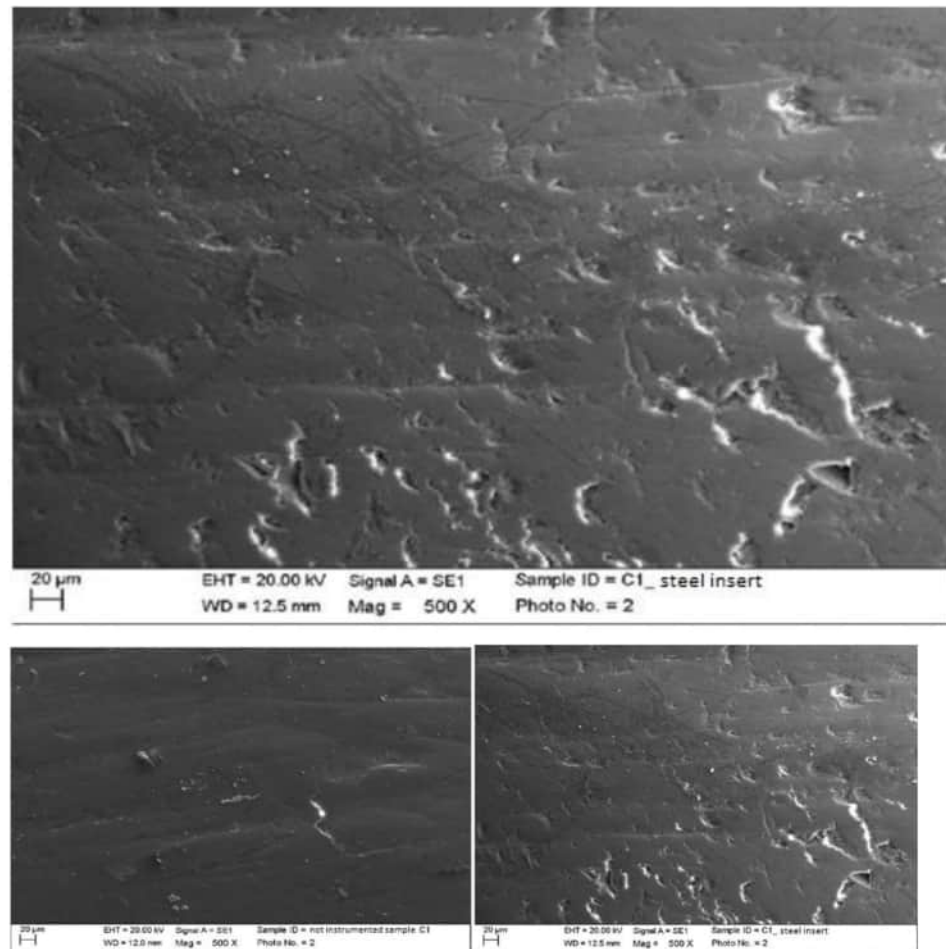
Instrumented composite with steel insert (PS, EMS, Nyon, Switzerland) mounted on Mini Piezon ultrasonic motor (EMS, Nyon, Switzerland).

The classic insert created light linear scratches on the surface without leaving accumulations of steel. The other irregularities were not due to the instrumentation, but to the finishing treatment of the material. Surface processing residues were removed from the treatment (Figure 6).

Figure 6. Instrumented composite sample C1 with steel insert (500 \times). Comparison before/after instrumentation.

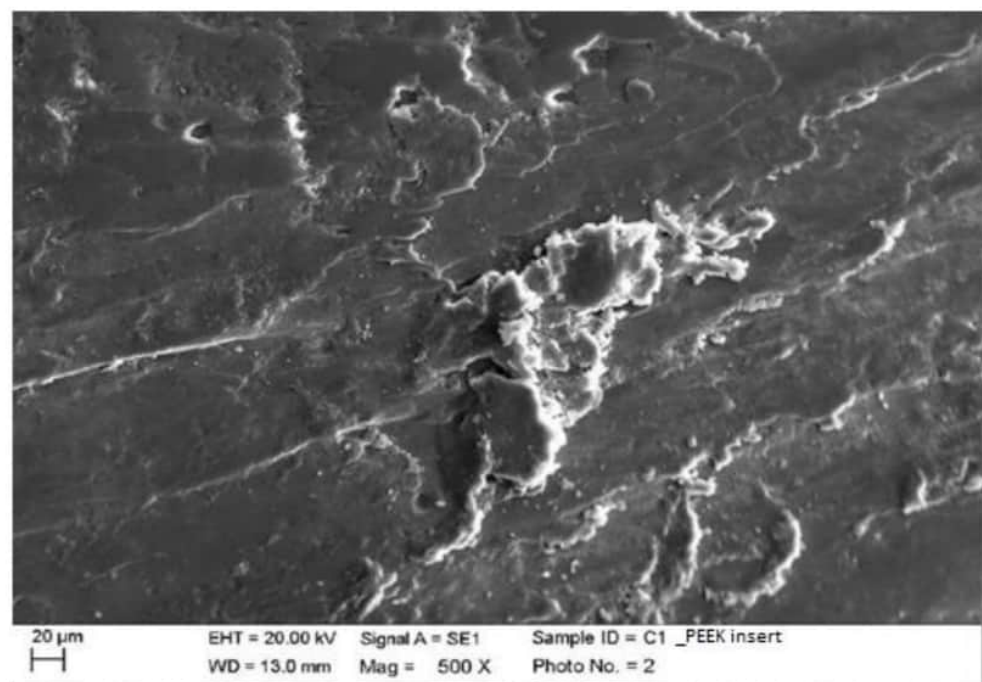
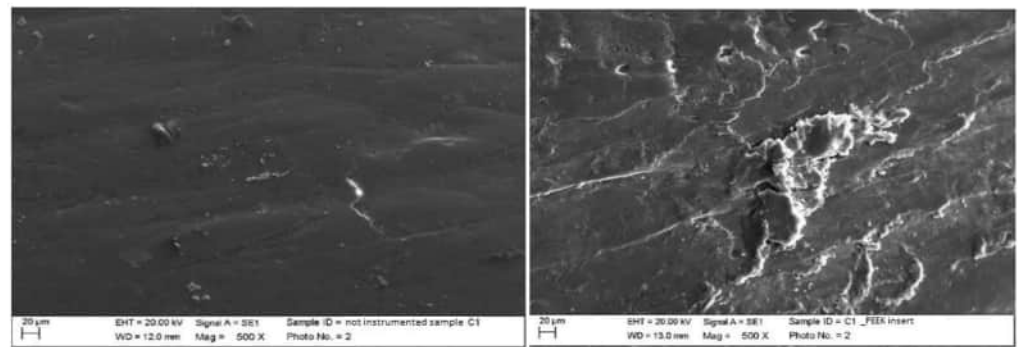
Instrumented composite with peek insert (ICS-IC1, Mectron, Carasco, Italy) mounted on MultiPiezo ultrasonic motor (Mectron, Carasco, Italy).

The peek on the composite material created important alterations by partially removing processing residues. The smaller residues were completely removed, but some surface irregularities remained. However, with the simple surface analysis, we could not define whether the alterations were due to etching or the deposition of the instrumentation material (Figure 7).

Figure 7. Instrumented composite sample C1 with peek insert (500 \times). Comparison before/after instrumentation.

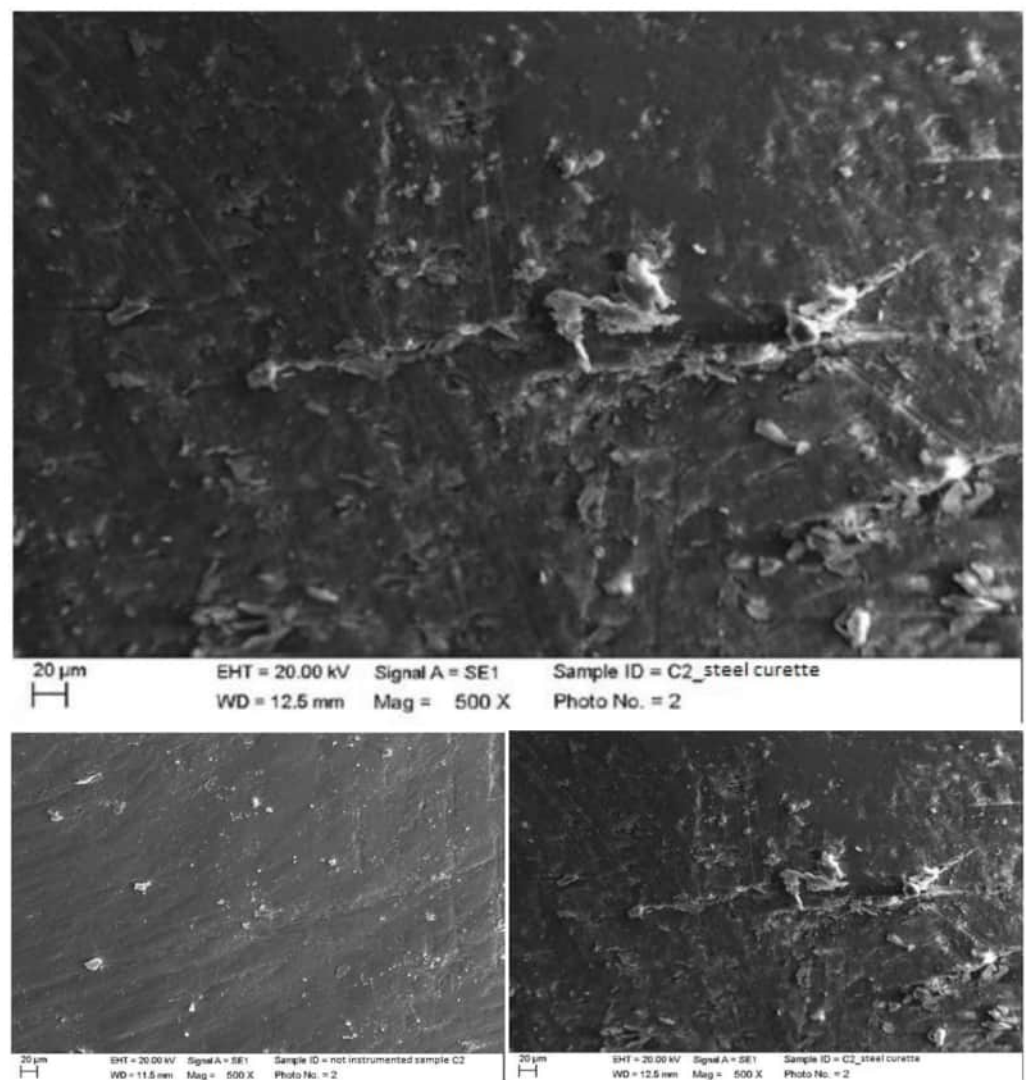
Instrumented composite with steel curette (PDT, Missoula, MT, USA).

The classic curette did not create important alterations to the surface of the material; it removed some residues, but left others (Figure 8).

Figure 8. Instrumented composite sample C2 with steel curette (500 \times). Comparison before/after instrumentation.

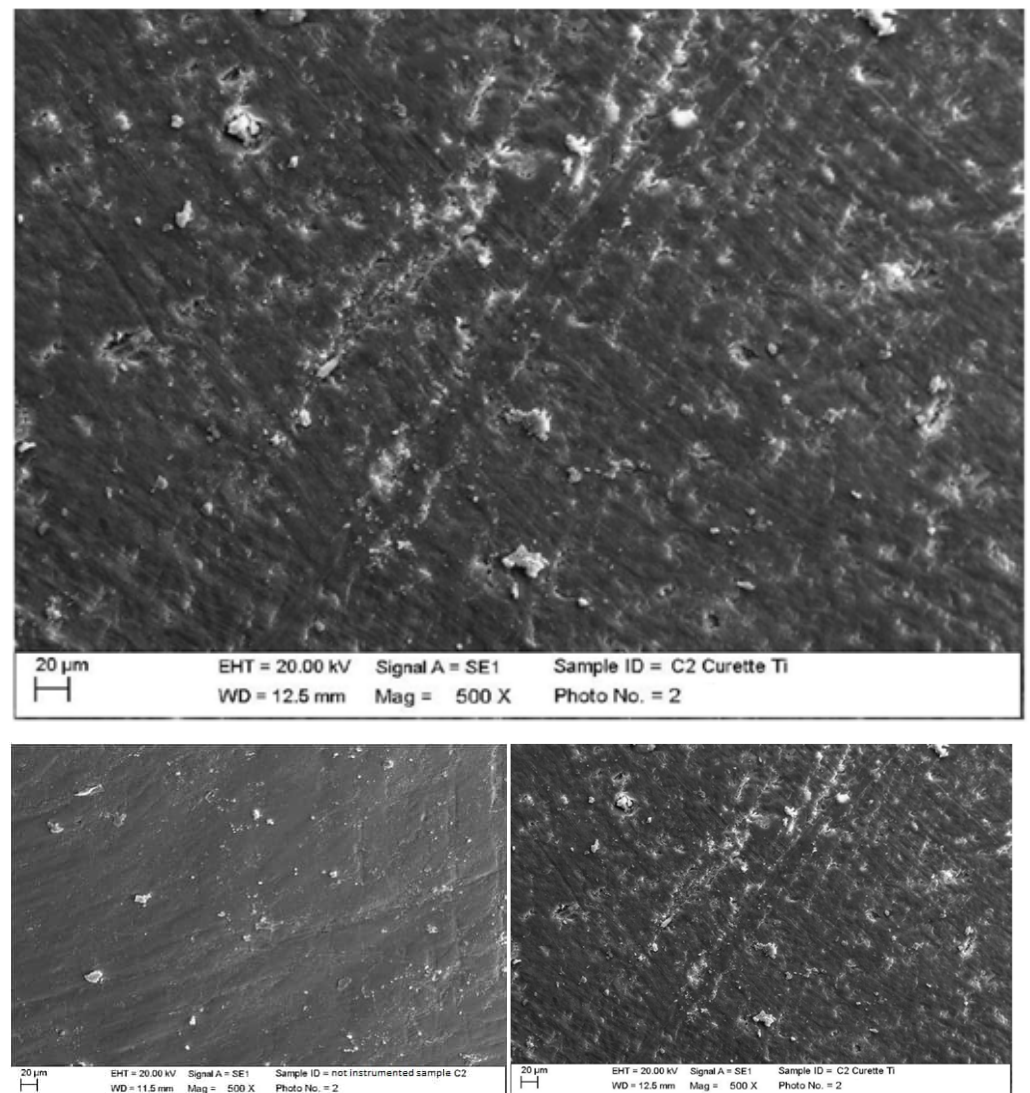
Instrumented composite with titanium curette (Wingrove 3-4, PDT, Missoula, MT, USA). The titanium curette created deeper incisions than the classic curette, completely removing finishing residues (Figure 9).

Figure 9. Instrumented composite sample C2 with titanium curette (500×). Comparison before/after instrumentation.

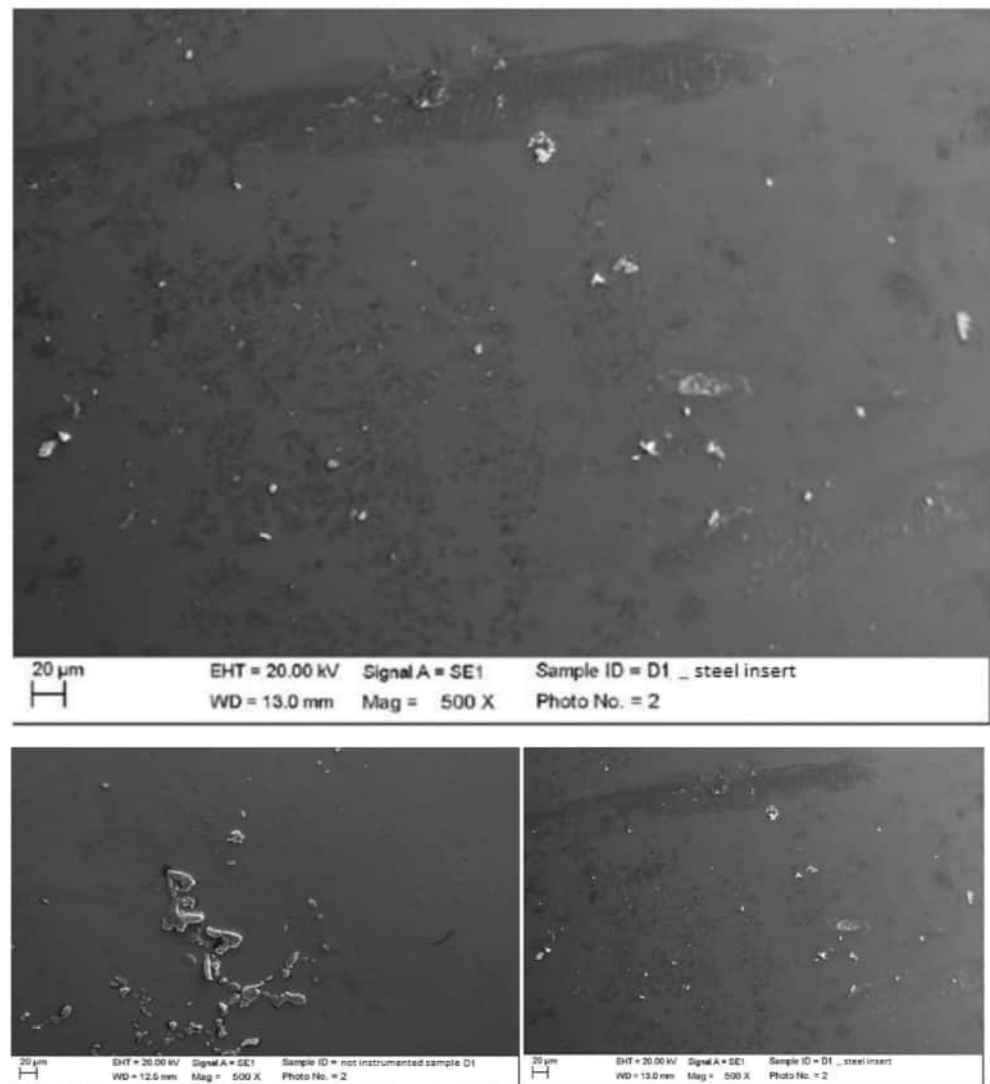
Instrumented disilicate with classic steel insert (PS, EMS, Nyon, Switzerland) mounted on Mini Piezon ultrasonic motor (EMS, Nyon, Switzerland).

The classic insert did not particularly alter the disilicate, also leaving processing residues, which was probably due to the fact that the residues themselves were larger than the other materials. There were slight scratches on the surface visible only at large magnifications (Figure 10).

Figure 10. Instrumented disilicate sample D1 with steel insert (500×). Comparison before/after instrumentation.

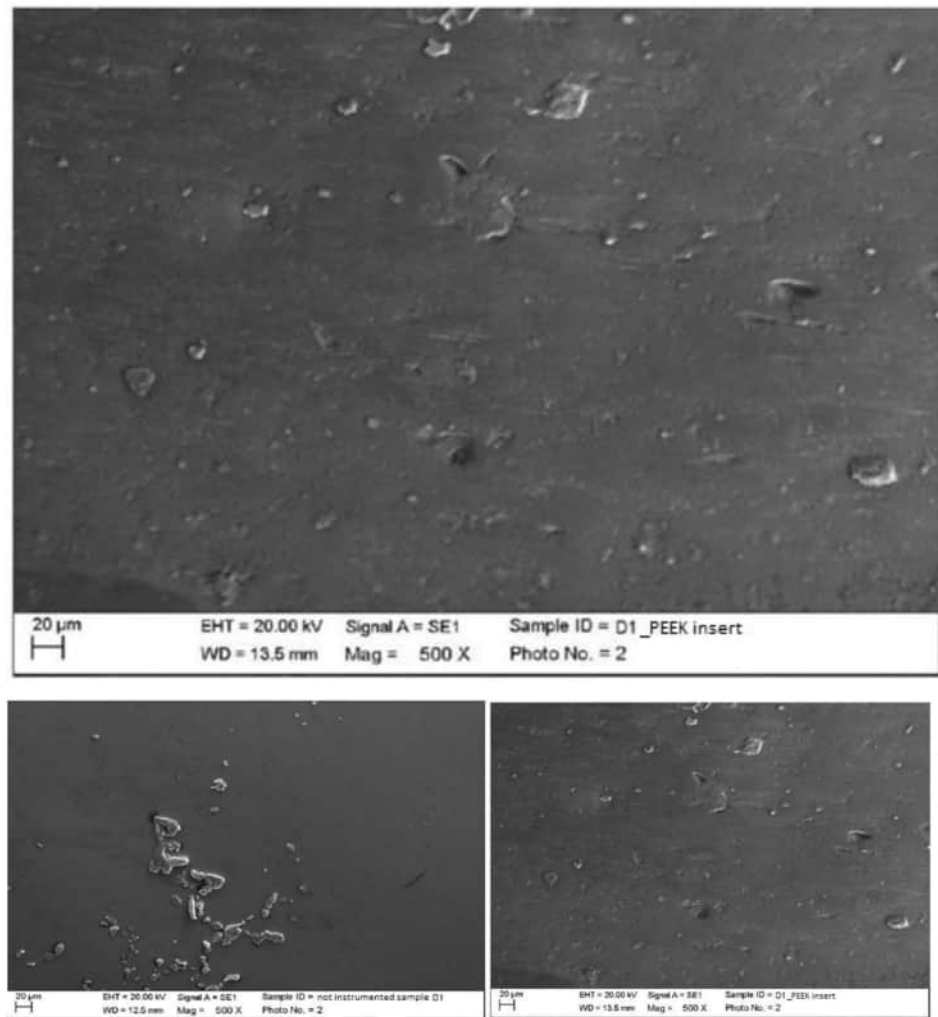
The peek created major alterations on the surface of the lithium disilicate. In fact, the dendritic formations (or primary crystals) representing the origin of the material were clearly visible, exposed precisely following the instrumentation of the surface itself. However, it was not possible with surface analysis to establish whether the formations were abraded disilicate or residual peek; to verify this, chemical–physical analysis of the surface should be carried out. A photo was taken at 3800 magnification, where it is possible to see in detail the areas from which the crystals were formed (Figure 11).

Figure 11. Instrumented disilicate sample D1 with peek insert (500×). Comparison before/after instrumentation.

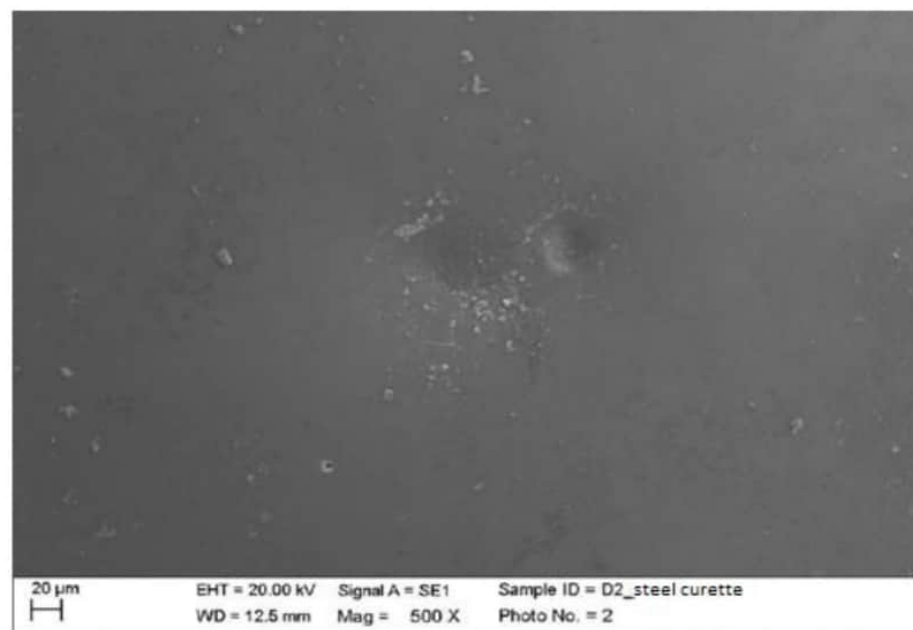
Instrumented disilicate with steel curette (PDT, Missoula, MT, USA).

The classic curette created almost no effect on the disilicate, other than the slight accumulation of the instrumentation materials (Figure 12).

Figure 12. Instrumented disilicate sample D2 with steel curette (500×).

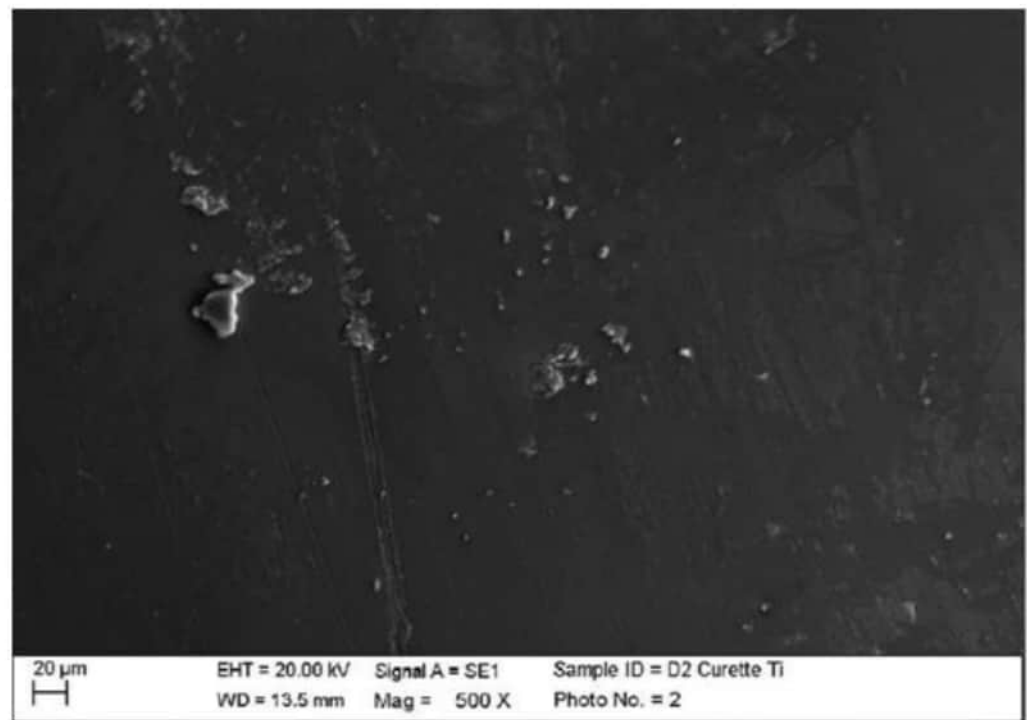
Instrumented disilicate with titanium curette (Wingrove 3-4, PDT, Missoula, MT, USA).

The titanium curette created important and deep surface incisions while leaving instrumentation residues embedded within the grooves, which could be partly titanium pieces and partly pieces of silicone residues (Figure 13).

Figure 13. Instrumented disilicate sample D2 with titanium curette (500×).

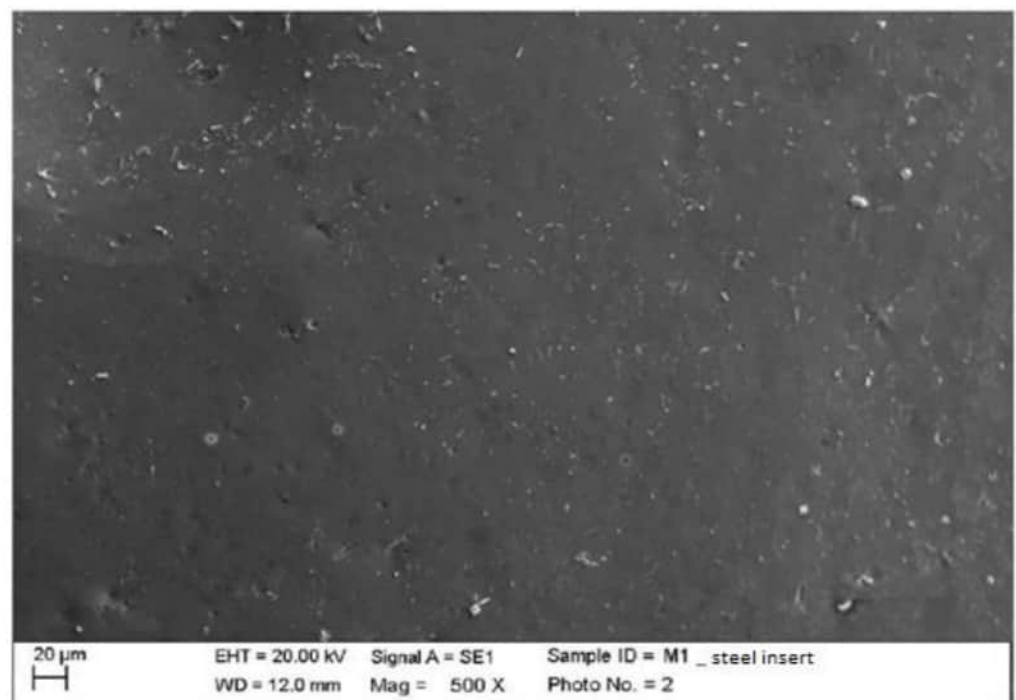
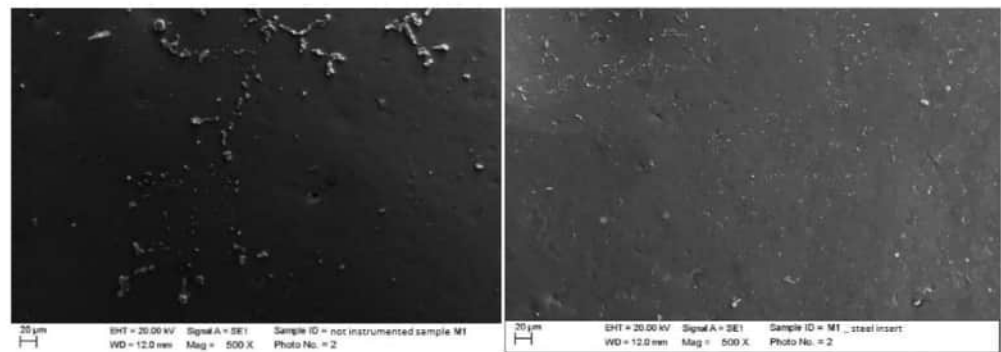
Instrumented ceramic with steel insert (PS, EMS, Nyon, Switzerland) mounted on Mini Piezon ultrasonic motor (EMS, Nyon, Switzerland).

The classic insert eliminated finishing residues by replacing them with other instrumentation residues. The elimination of residues was clearly visible at the higher magnification, which was comparable to a thin flaking film (Figure 14).

Figure 14. Instrumented ceramic sample M1 with steel insert (500×). Comparison before/after instrumentation.

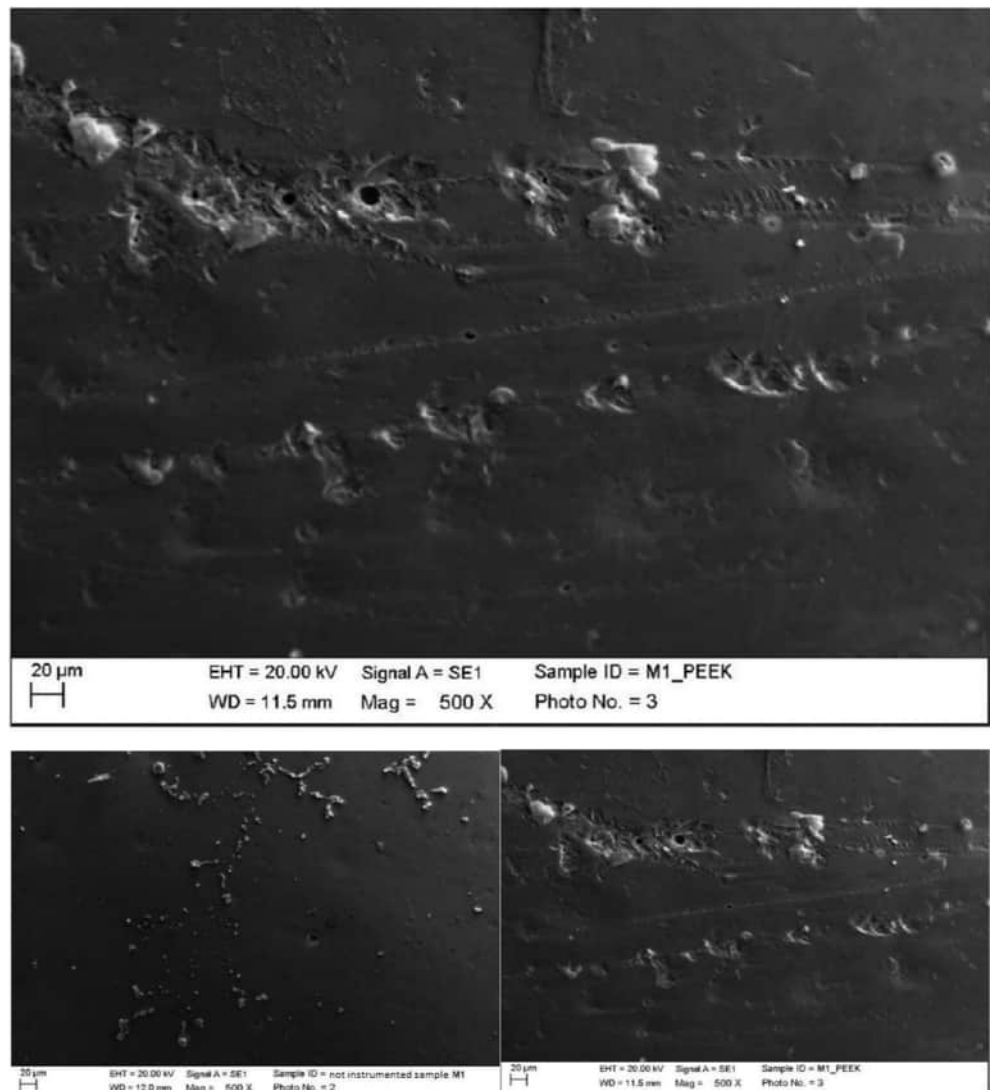
Instrumented ceramic with peek insert (ICS-IC1, Mectron, Carasco, Italy) mounted on ultrasonic motor, MultiPiezo (Mectron, Carasco, Italy).

The peek on the ceramic created horizontal and vertical alterations, but it was again not possible to establish the origin of these changes (Figure 15).

Figure 15. Instrumented ceramic sample M1 with peek insert (500×). Comparison before/after instrumentation.

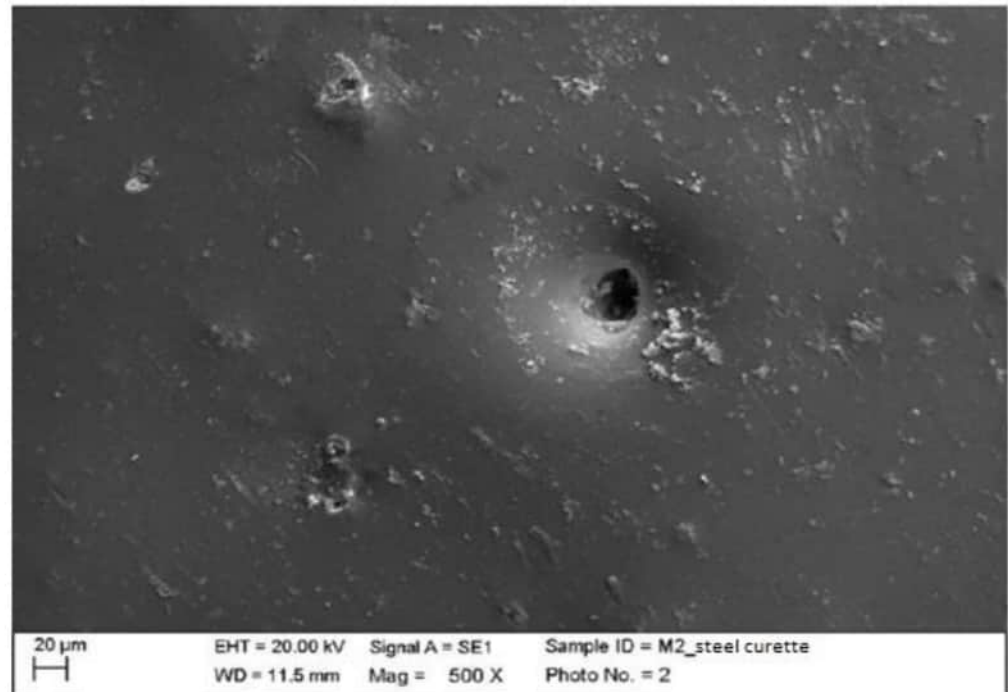
Instrumented ceramic with steel curette (PDT, Missoula, MT, USA).

The classic curette, being ceramic, a very hard material, hardly created any negative effects on the surface. The crater visible in photo X was due to the ceramic material itself, which was hard and brittle, but was not related to manual instrumentation (Figure 16).

Figure 16. Instrumented ceramic sample M2 with steel curette (500×).

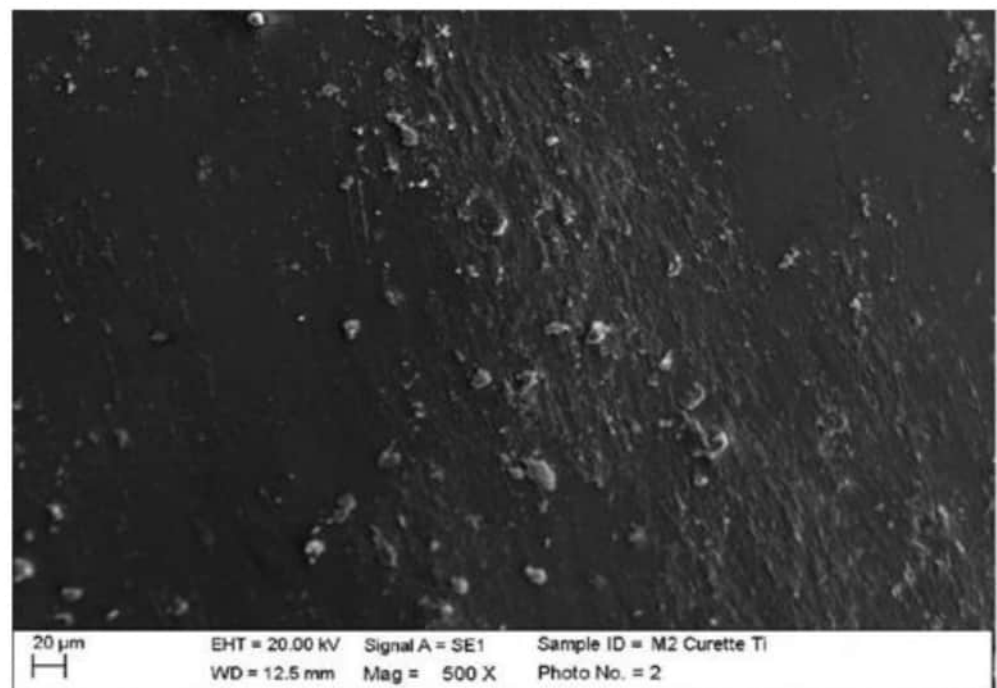
Instrumented ceramic with titanium curette (Wingrove 3-4, PDT, Missoula, MT, USA).

The titanium curette did not create particular damage but left numerous large residues, both ceramic and titanium (Figure 17).

Figure 17. Instrumented ceramic sample M2 with titanium curette (500×).

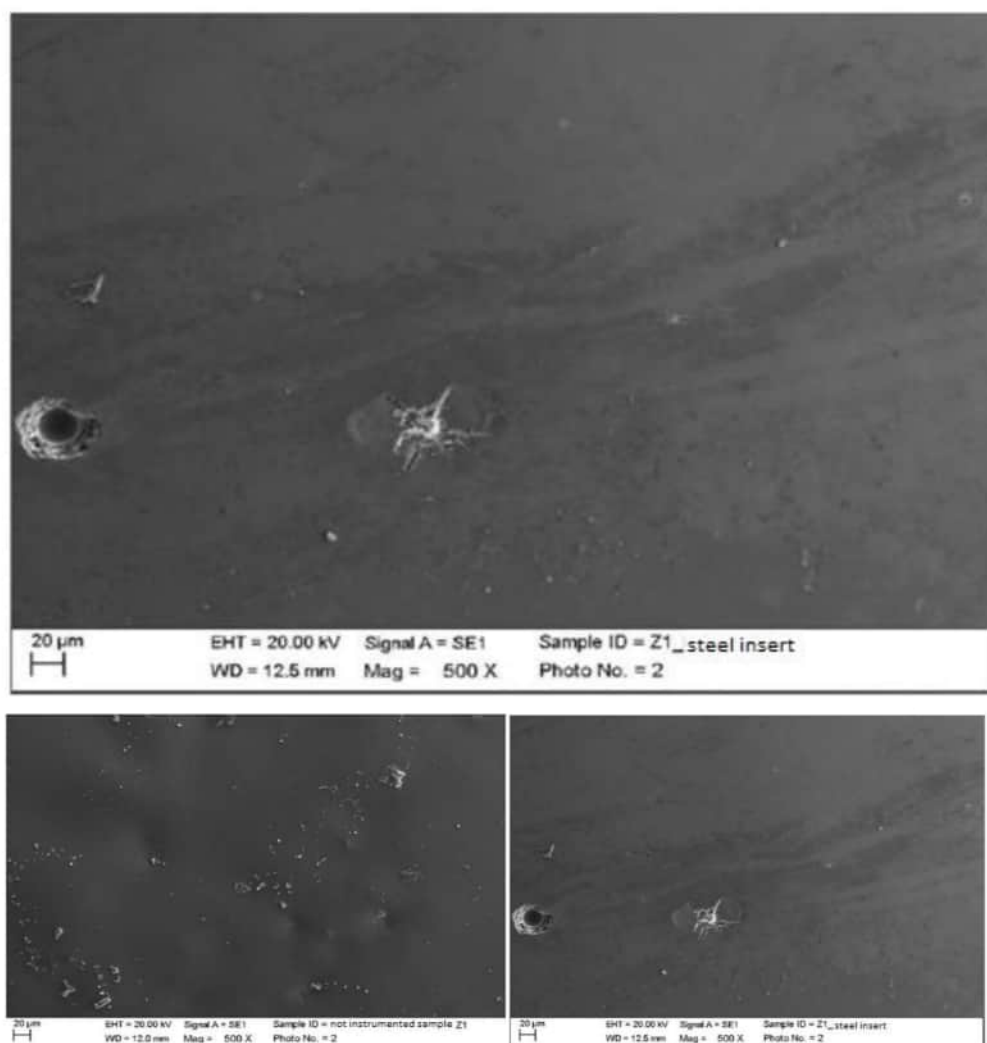
Instrumented zirconium with steel insert (PS, EMS, Nyon, Switzerland) mounted on Mini Piezon ultrasonic motor (EMS, Nyon, Switzerland).

The classic insert created a large fracture, clearly visible at 2000 magnification, in an area that was previously irregular. The crater visible in image 5.42 was not due to the instrumentation, but, as seen previously in the ceramic, to the hardness/fragility of the material (material defect). The trimming residues were removed (Figure 18).

Figure 18. Instrumented zirconium sample Z1 with steel insert (500×). Comparison before/after instrumentation.

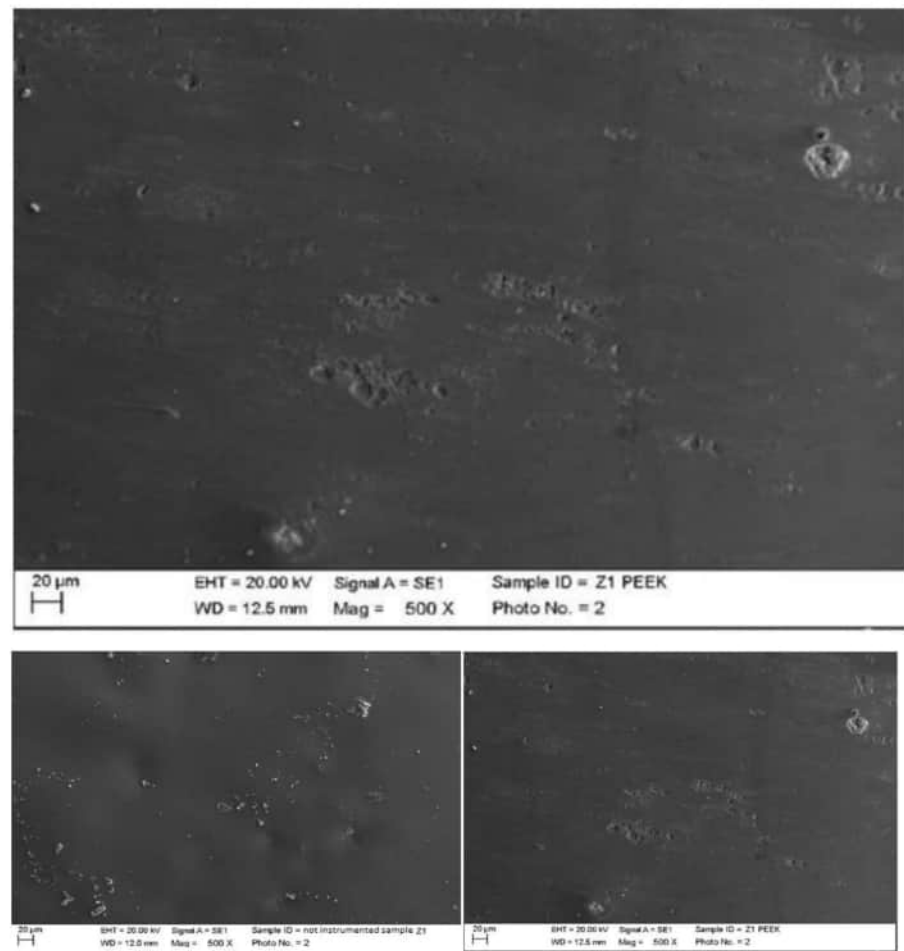
Instrumented zirconium with peek insert (ICS-IC1, Mectron, Carasco, Italy) mounted on ultrasonic motor, MultiPiezo (Mectron, Carasco, Italy).

The peek created alterations on the zirconium; however, it was not possible to establish the cause. The instrumentation areas were clearly visible (Figure 19).

Figure 19. Instrumented zirconium sample Z1 with peek insert (500×). Comparison before/after instrumentation.

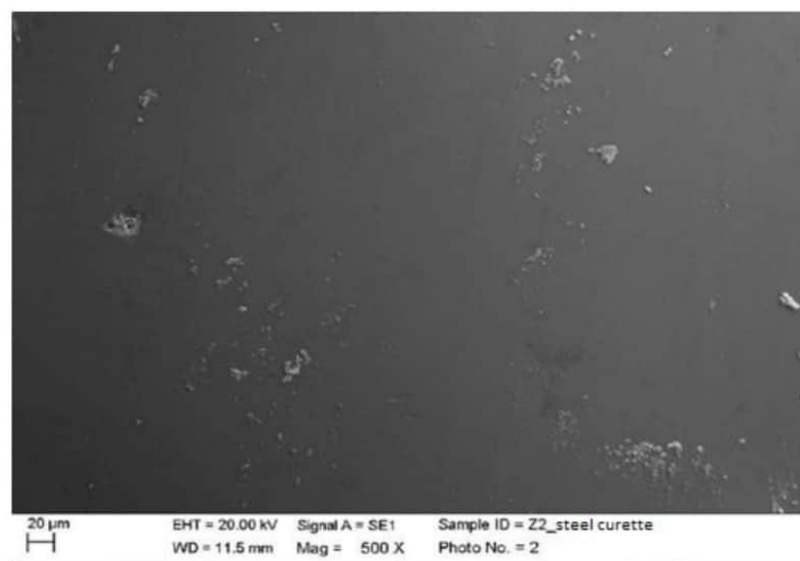
Instrumented zirconium with steel curette (PDT, Missoula, MT, USA).

At maximum magnification, incisions and surface residues were visible on the zirconium part treated with a steel curette (Figure 20).

Figure 20. Instrumented zirconium sample Z2 with steel curette (500×).

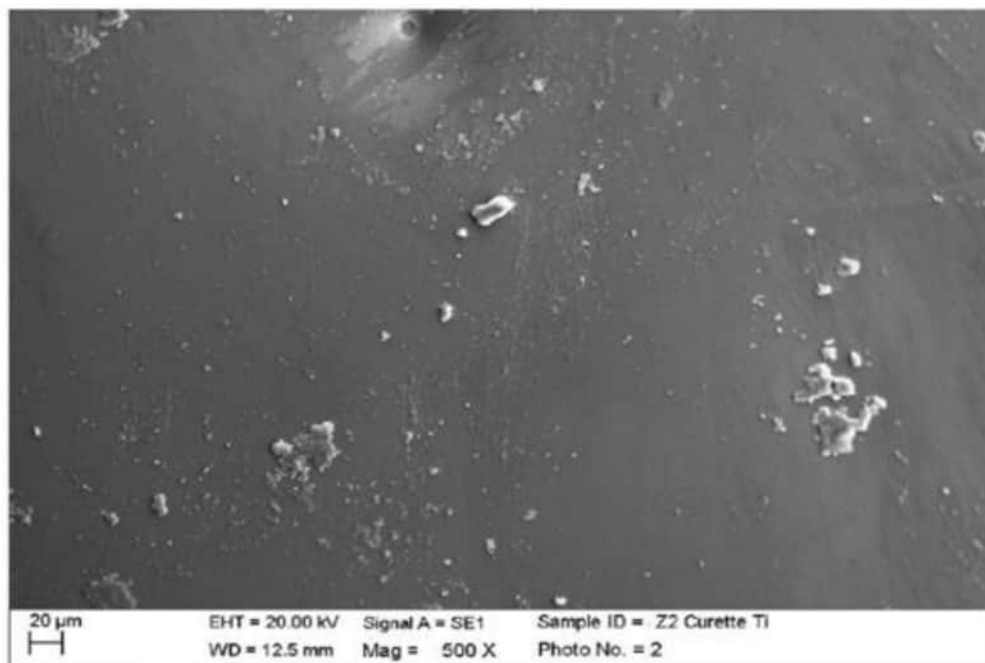
Instrumented zirconium with titanium curette (Wingrove 3-4, PDT, Missoula, MT, USA). The titanium curette created slight superficial incisions visible at higher magnifications, leaving few processing residues. On the left side of the enlargement, 2000 super-surface residues from finishing were still visible (Figure 21).

Figure 21. Instrumented zirconium sample Z2 with titanium curette (500×).

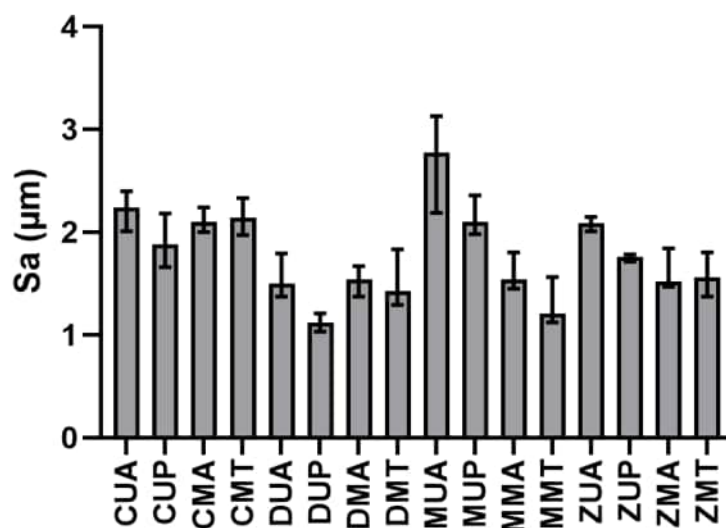
Two Kruskal-Wallis tests were performed in the statistical analysis of the roughness values. In both cases, the 80 tests (five measurements × four materials × four instruments) were divided into four groups: composite, lithium disilicate, metal ceramic, and zirconium ceramic for material analysis, and ultrasonic-steel, ultrasonic-peek, manual-steel, and manual-titanium for instrumentation analysis. The null hypothesis, i.e., that all groups of samples came from the same distribution, was rejected in both tests, confirming the significance of the influence of both the material and the instrumentation ($p < 0.05$). The bar diagrams representing the median, maximum, and minimum values of S_a for each combination of material and instrumentation are shown in Figure 22, the legend of which is shown in Table 1.

The Kruskal-Wallis test confirmed that not all groups were from the same population, but did not provide information about which groups differed from each other. To determine between which materials and equipment there was a significant difference, a Bonferroni post hoc test was performed (Tables 2 and 3). p -values less than 0.05 corresponded to pairs of materials and instruments that had a significant difference.

Figure 22. Median and extreme values of Sa for each combination. The material (C: composite, D: lithium disilicate, M: metal ceramic, Z: zirconium ceramic) and instrumentation (UA: ultrasonic-steel, UP: ultrasonic-peek, MA: manual-steel, MT: manual-titanium) are indicated along the abscissa axis.
