Combined use of deformation and structural analysis for the structural damage assessment of heritage buildings: A case study in the Liguria region (Italy)

Giulio Lucio Sergio Sacco, Chiara Ferrero^{*}, Carlo Battini, Chiara Calderini

Department of Civil, Chemical and Environmental Engineering, University of Genoa, Via Montallegro 1, 16145 Genoa, Italy

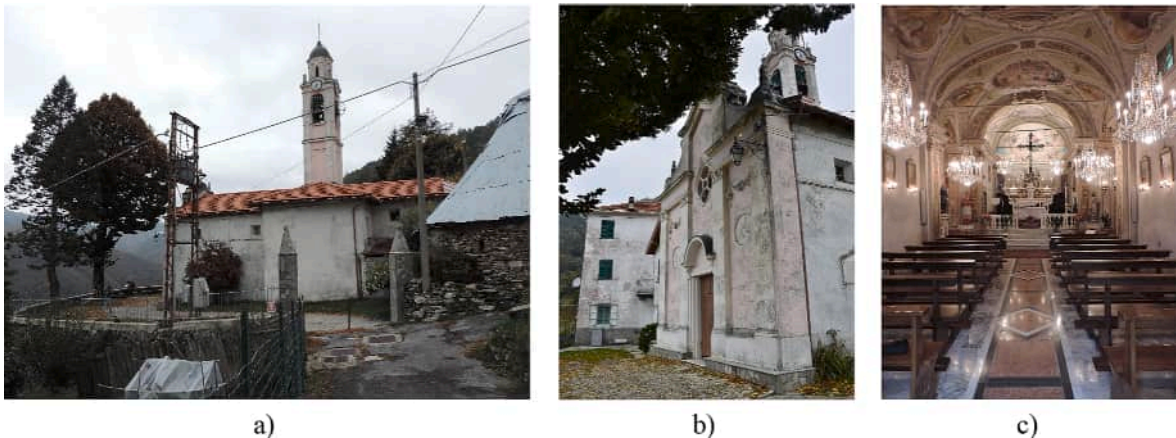
Fig. 1. San Carlo Borromeo church: a) south-eastern façade, b) front façade, c) interior.

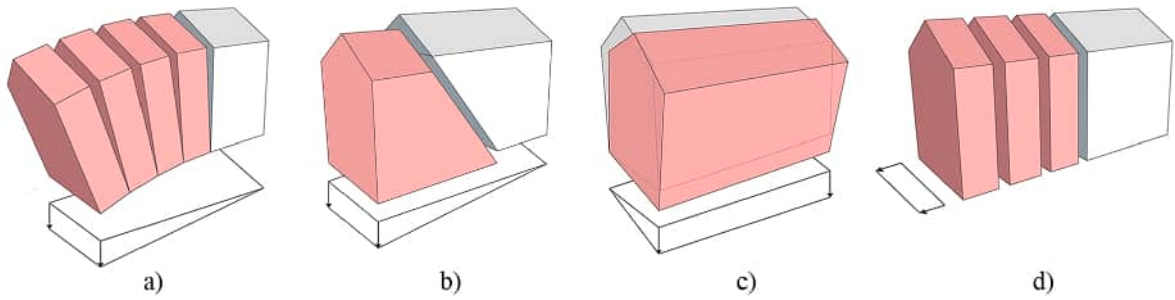
Considering the damage mechanisms shown in Fig. 12, the global rotation of the buildings towards valley (Fig. 6) can be attributed to the vertical component of the slow-moving landslide movement. The cracks in the floor oriented perpendicular to the landslide direction (coloured in blue in Fig. 5c) and the vertical cracks in the longitudinal walls (Fig. 5b) can instead be attributed to the horizontal component of the landslide movement. These cracks clearly indicate that the church suffered an extension in the direction of the slow-moving landslide (see Fig. 12d). When an extension mechanism takes place, vertical cracks propagating from the level of the

Fig. 12. Damage mechanisms of historic masonry churches exposed to slow-moving: a) hogging, b) shear deformation, c) global rigid rotation, d) extension [8].

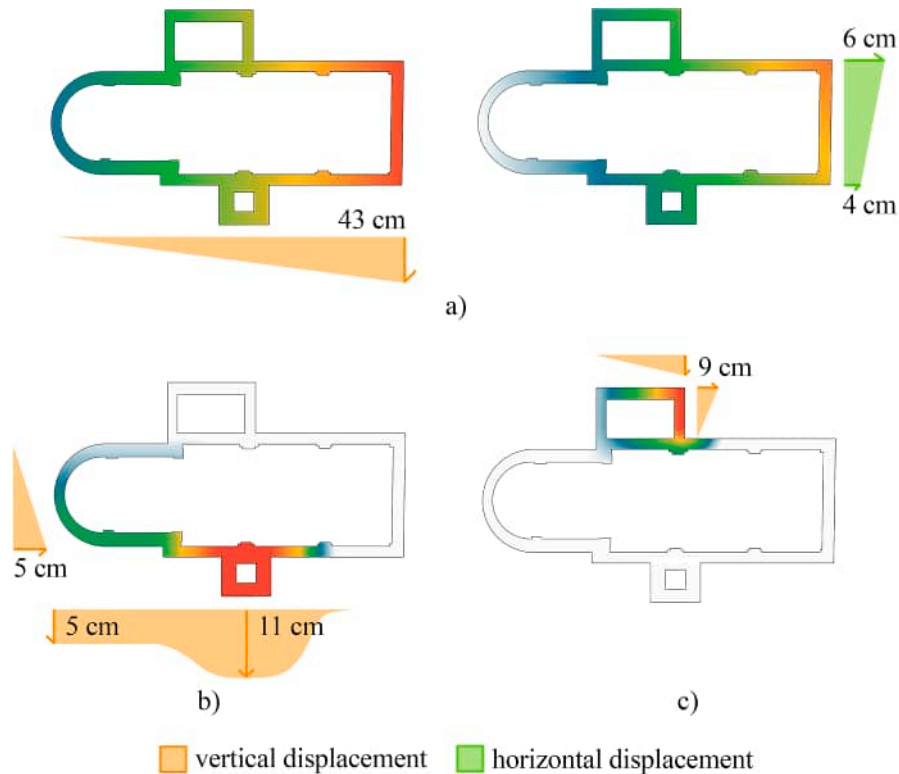
Fig. 13. Displacement fields: a) global displacement produced by the slow-moving landslide (on the left vertical component, $u_{global,v}$; on the right horizontal component, $u_{global,h}$); b) local vertical settlement of the left side of the church ($u_{left,v}$); c) local vertical settlement of the right chapel ($u_{right,v}$).

Based on the previous considerations, the displacements produced at the base of the church by the slow-moving landslide and foundation settlements, which are responsible for damage and deformations, can be represented through three displacements fields, one global, affecting the entire church (Fig. 13a), and two local (Fig. 13b-c). The global displacement corresponds to the displacements induced by the slow-moving landslide and has both vertical ($u_{global,v}$) and horizontal ($u_{global,h}$) components (see Fig. 13 on the left and on the right, respectively). The local displacements represent the vertical settlements of the left side of the church ($u_{left,v}$, Fig. 13b) and the right chapel ($u_{right,v}$, Fig. 13c). The value of the vertical component of the global displacement ($u_{global,v}$) was estimated based on the rotation measured along the length of the nave ($\delta = 1.16^\circ$), which was extended to the entire building (see angle Δ in Fig. 6). In such a way, a vertical displacement of 43 cm between the apse and the façade was obtained (Fig. 13a on the left). The value of the horizontal component ($u_{global,h}$) was taken equal to the sum of the width of the cracks in the floor of the nave, which was found to be slightly different on the left (4 cm) and right (6 cm) sides of the building (Fig. 13a on the right). The values of the vertical settlement of the left side of the building and the right chapel were taken equal to the values estimated through the deformation analysis (see Section 3.2).

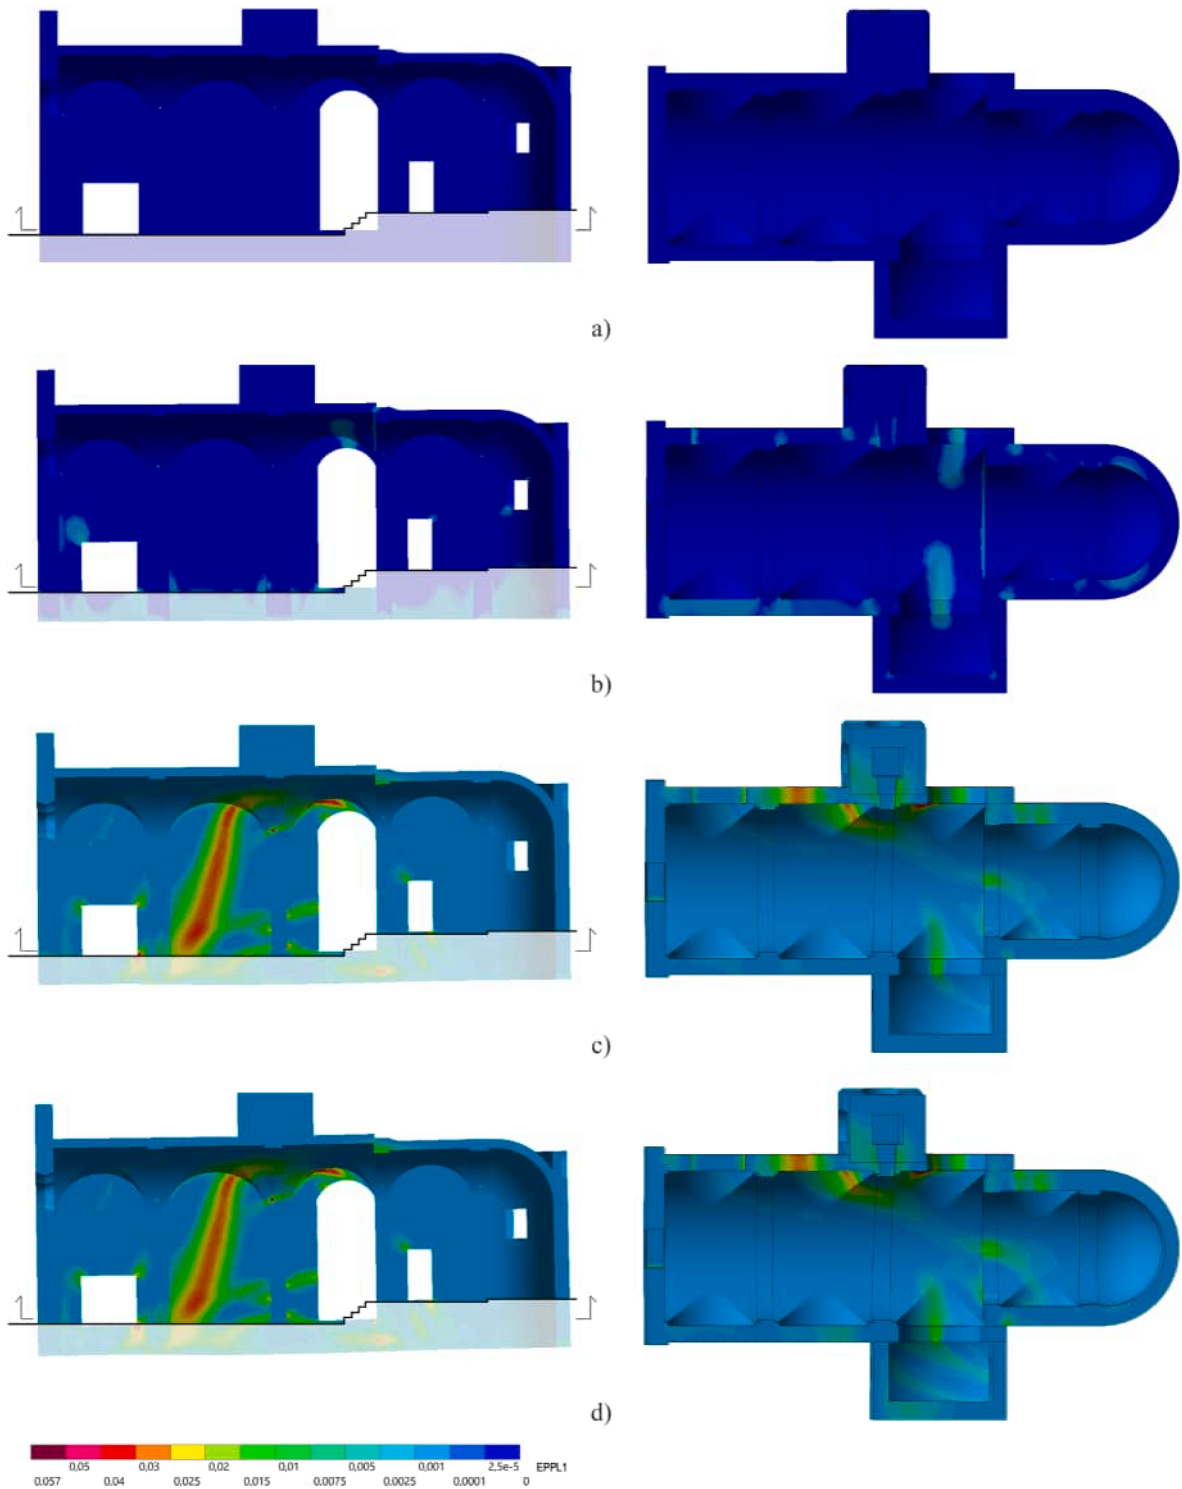
Fig. 16. Maximum principal plastic strain obtained at the end of each step of the sequence of loads and displacement fields identified in Fig. 15: a) step 0, b) step 1, c) step2, d) step 3. On the left: left side of the church (section AA’); on the right, plan (vaults and base of the walls, see the cutting plane line indicated on the left).

Fig. 16 shows the results obtained at the end of each step of application of the displacement fields in terms of maximum principal plastic strain, which provides an indication of the crack formation. The results are presented in elevation for the left side of the church (section AA'), which is the most representative (see Fig. 16 on the left), and in plan for the vaults and the base of the walls (see Fig. 16 on the right). The plan is obtained by cutting the numerical model approximately at the level of the floor of the nave (the cutting plane line is shown in Fig. 16 on the left). The application of the self-weight (step 0) did not produce any damage (Fig. 16a), while the application of the first third of the landslide-induced global displacements (step 1) resulted in limited damage (Fig. 16b), mostly localized at the base of the longitudinal walls and at mid-span of the arches that separate the nave from the lateral chapels (third bay behind the façade). As shown in Fig. 16c, the application of the settlement of the left side of the building and the second third of the global displacements (step 2) produced a significant worsening of the damage state of the church. Extensive cracks appeared in the left longitudinal wall as well as in the vaults of nave, presbytery, and right chapel. Conversely, the application of the settlement of the right chapel and the last third of the global displacements (step 3, Fig. 16c) did not significantly worsen the damage level, except in the right chapel, as expected, where further damage occurred in both walls and vaults. A vertical and diagonal crack also appeared in the right

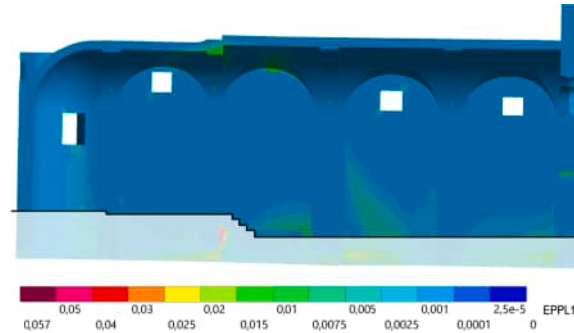
Fig. 17. Maximum principal plastic strain obtained in the right side of the church (section BB') at the end of the sequence of application of the loads and displacement fields identified in Fig. 15 (end of step 3).
