# Engineering Failure Analysis

## Combined use of deformation and structural analysis for the structural damage assessment of heritage buildings: A case study in the Liguria region (Italy)

Giulio Lucio Sergio Sacco, Chiara Ferrero<sup>\*</sup>, Carlo Battini, Chiara Calderini

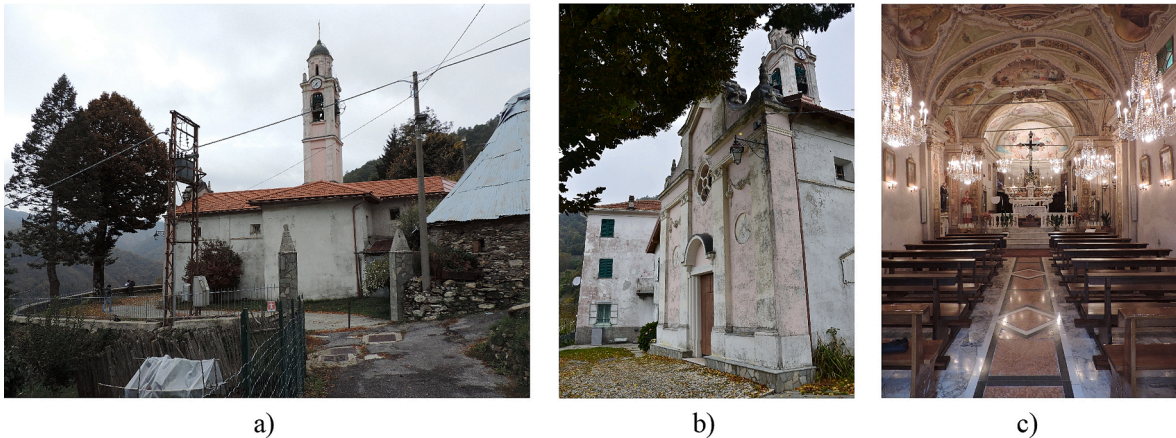
Fig. 1. San Carlo Borromeo church: a) south-eastern façade, b) front façade, c) interior.

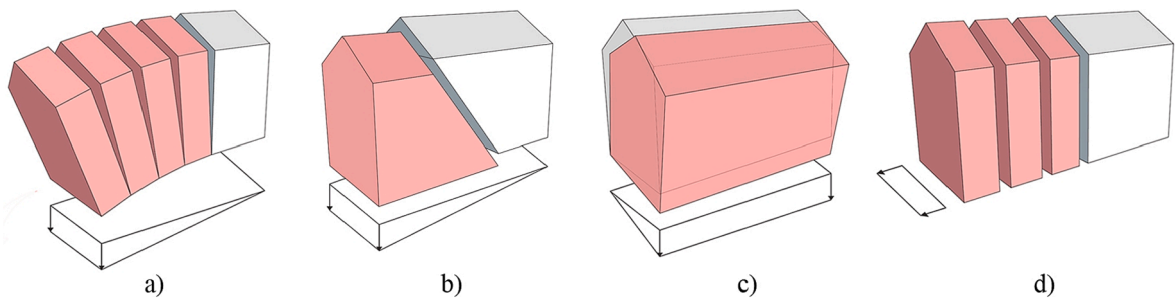
Considering the damage mechanisms shown in Fig. 12, the global rotation of the buildings towards valley (Fig. 6) can be attributed to the vertical component of the slow-moving landslide movement. The cracks in the floor oriented perpendicular to the landslide direction (coloured in blue in Fig. 5c) and the vertical cracks in the longitudinal walls (Fig. 5b) can instead be attributed to the horizontal component of the landslide movement. These cracks clearly indicate that the church suffered an extension in the direction of the slow-moving landslide (see Fig. 12d). When an extension mechanism takes place, vertical cracks propagating from the level of the

**Fig. 12.** Damage mechanisms of historic masonry churches exposed to slow-moving: a) hogging, b) shear deformation, c) global rigid rotation, d) extension [8].

Looking at the types of damage shown in Fig. 12 and considering the direction of the slow-moving landslide affecting Cassingheno village, which is parallel to the direction of the longitudinal axis of San Carlo Borromeo church, the cracks in the vaults can hardly be attributed to the slow-moving landslide. Being oriented in the same direction as the landslide or exhibiting a concentric pattern around the belltower, they can indeed be attributed to differential foundation settlements and, in particular, to the larger settlement of the left side of the building with respect to the right side. Although no information about the soil under San Carlo Borromeo church is available, it is reasonable to assume that the differential foundation settlements may have been caused by heterogeneities of the soil and/or differences in the process of soil consolidation under the different parts of the building. It is likely that these foundation settlements are also responsible for the damage and deformations of the transverse arches (Fig. 7) and the differential vertical

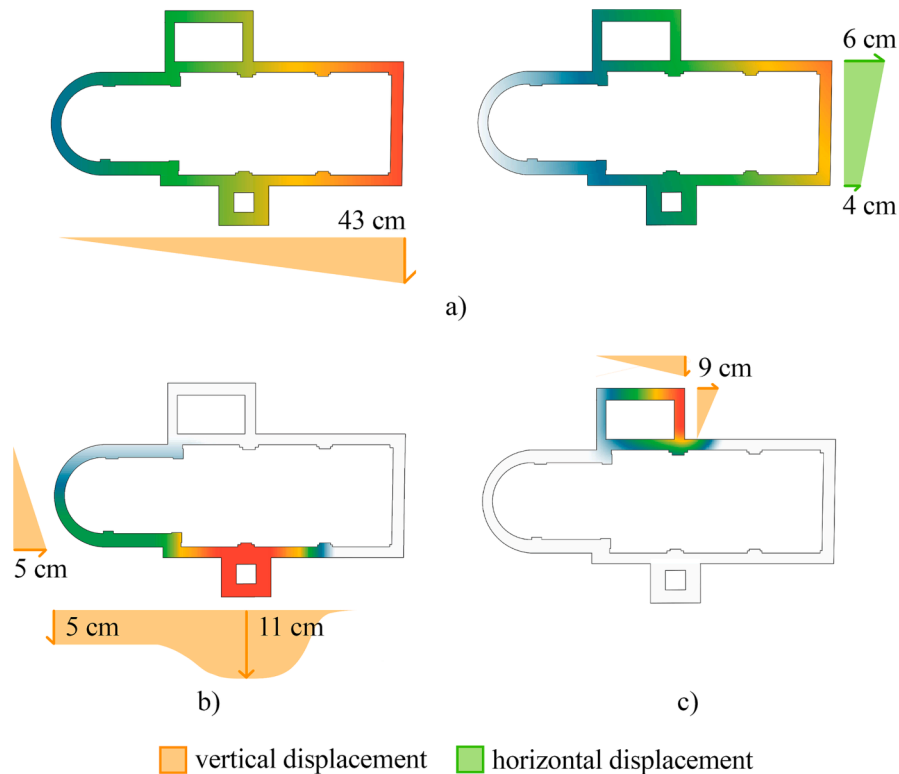
**Fig. 13.** Displacement fields: a) global displacement produced by the slow-moving landslide (on the left vertical component,  $u_{global,v}$ ; on the right horizontal component,  $u_{global,h}$ ); b) local vertical settlement of the left side of the church ( $u_{left,v}$ ); c) local vertical settlement of the right chapel ( $u_{right,v}$ ).

Based on the previous considerations, the displacements produced at the base of the church by the slow-moving landslide and foundation settlements, which are responsible for damage and deformations, can be represented through three displacements fields, one global, affecting the entire church (Fig. 13a), and two local (Fig. 13b-c). The global displacement corresponds to the displacements induced by the slow-moving landslide and has both vertical ( $u_{global,v}$ ) and horizontal ( $u_{global,h}$ ) components (see Fig. 13 on the left and on the right, respectively). The local displacements represent the vertical settlements of the left side of the church ( $u_{left,v}$ , Fig. 13b) and the right chapel ( $u_{right,v}$ , Fig. 13c). The value of the vertical component of the global displacement ( $u_{global,v}$ ) was estimated based on the rotation measured along the length of the nave ( $\delta = 1.16^\circ$ ), which was extended to the entire building (see angle  $\Delta$  in Fig. 6). In such a way, a vertical displacement of 43 cm between the apse and the façade was obtained (Fig. 13a on the left). The value of the horizontal component ( $u_{global,h}$ ) was taken equal to the sum of the width of the cracks in the floor of the nave, which was found to be slightly different on the left (4 cm) and right (6 cm) sides of the building (Fig. 13a on the right). The values of the vertical settlement of the left side of the building and the right chapel were taken equal to the values estimated through the deformation analysis (see Section 3.2).
